# Perkins Park Existing Conditions Report

November 19, 2020 //////////////////////////////////////

**Ecological Concerns, Inc**  
Josh Fodor, Principal  
Rita Manna, Project Manager

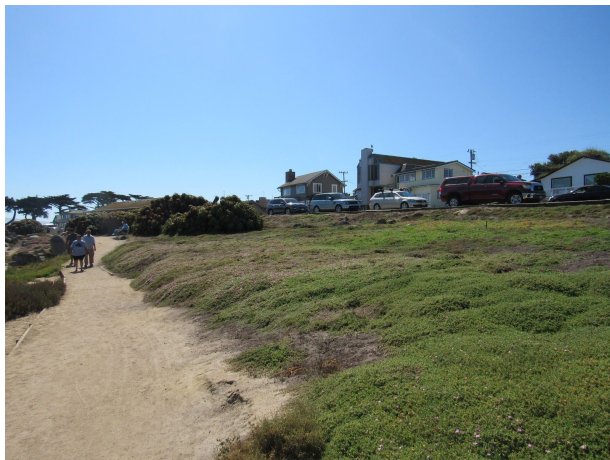
*Above Left: Gardens with high coverage of Healthy and Thriving “Magic Carpet” ice plant, located on the south side of the park near Borg’s Motel.*

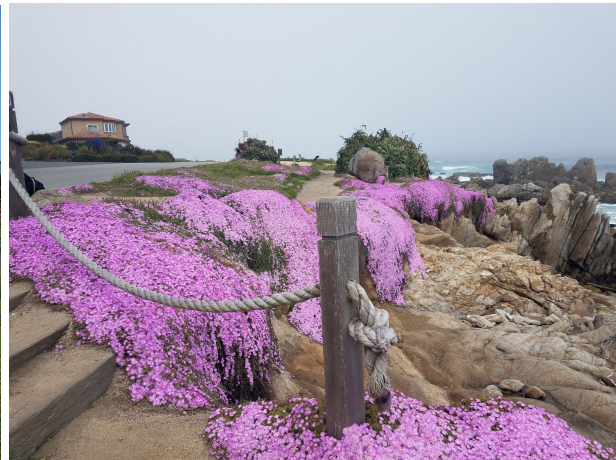
*Above Right: Healthy and Thriving “Magic Carpet” ice plant with high coverage, located near Esplanade Park.*

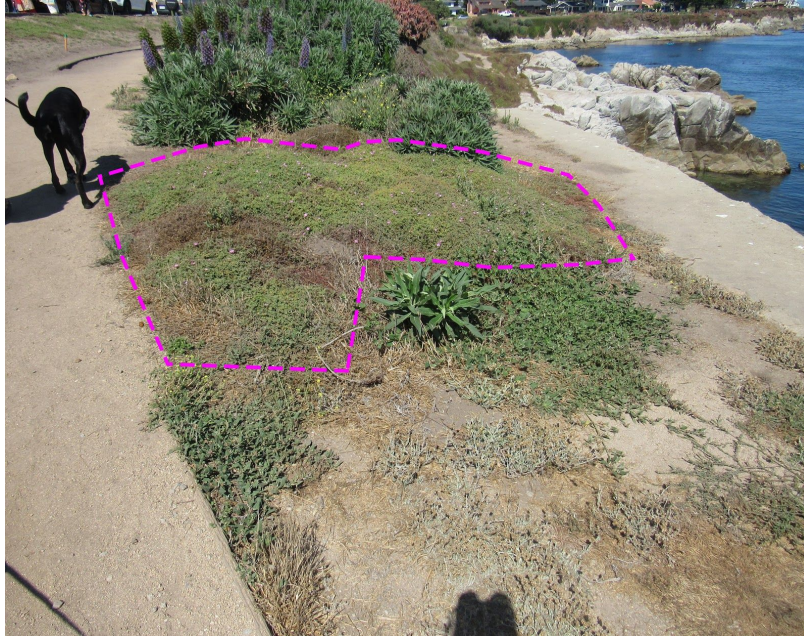
*Above: Gardens with 45% coverage of Healthy and Thriving “Magic Carpet” ice plant, located on the south side of the park. “Magic Carpet” ice plant is outlined above within the pink dashed line.*

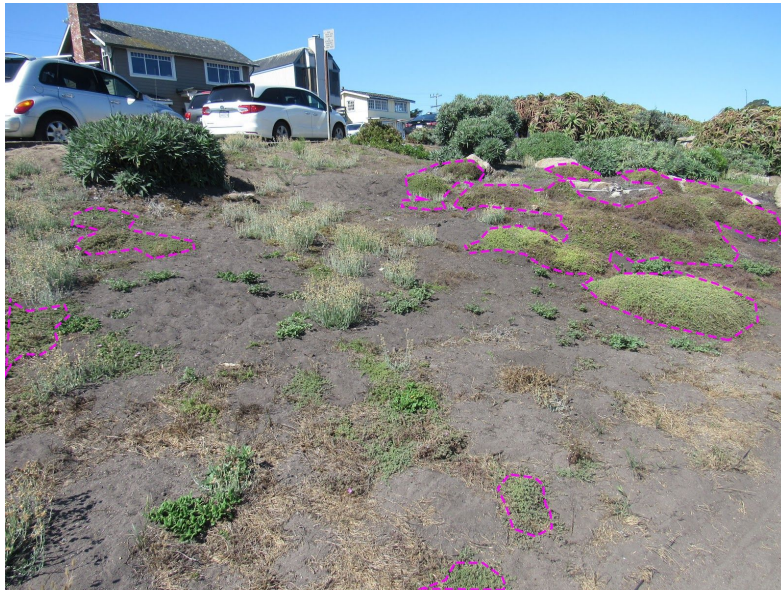
*Above: A garden with low concentrations of “Magic Carpet” ice plant. However, the few stands of ice plant that are found within the space are considered to be Healthy and Thriving. “Magic Carpet” ice plant is outlined above within the pink dashed line.*

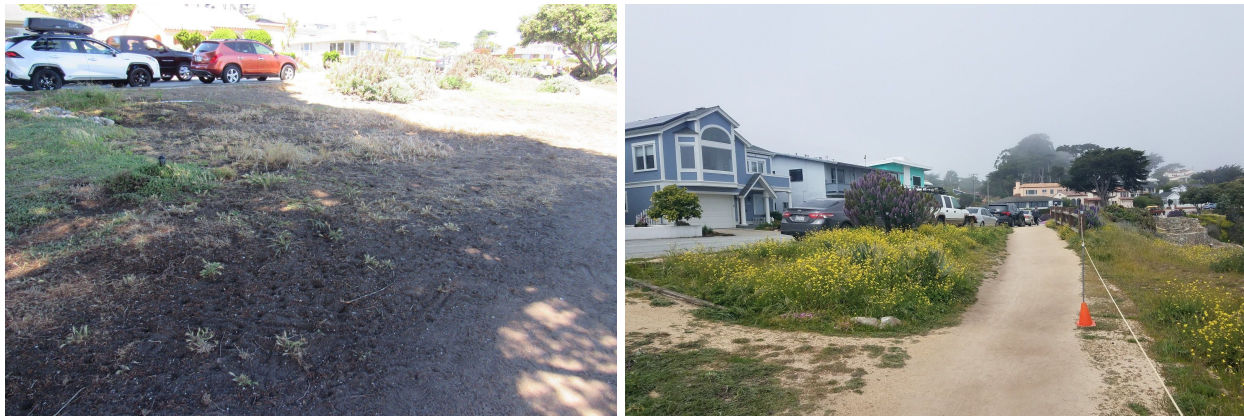
Above Left: Bare soil and weeds along the stretch of Cypress trees in Perkins Park.

Above Right: Landscape areas near Sea Palm Ave. are overrun with weeds.

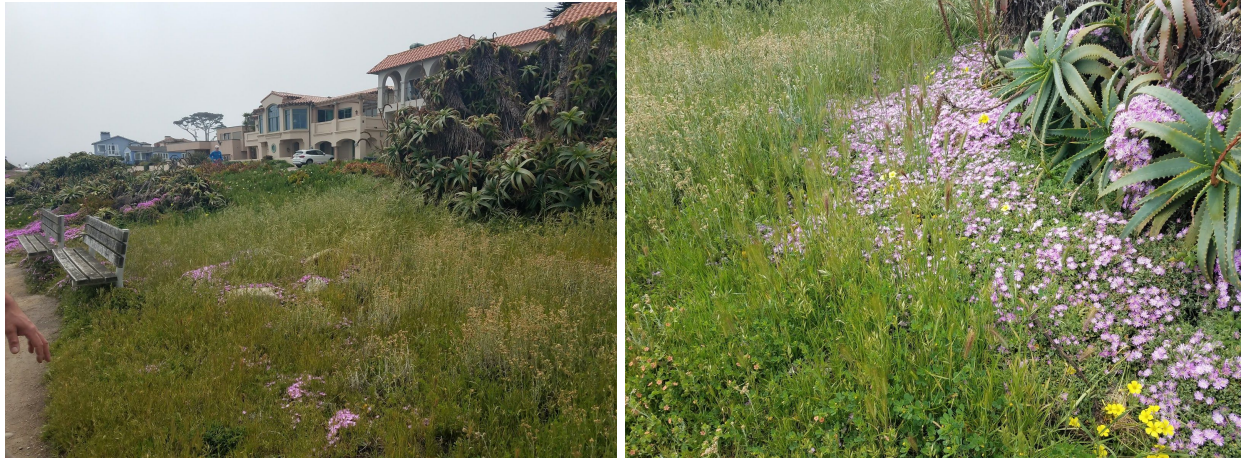
*Above Left: Non-native grasses inundate a stand of “Magic Carpet” ice plant near Esplanade Park.*

*Above Right: Detail image of weedy grasses within a stand of “Magic Carpet” ice plant near Esplanade Park.*

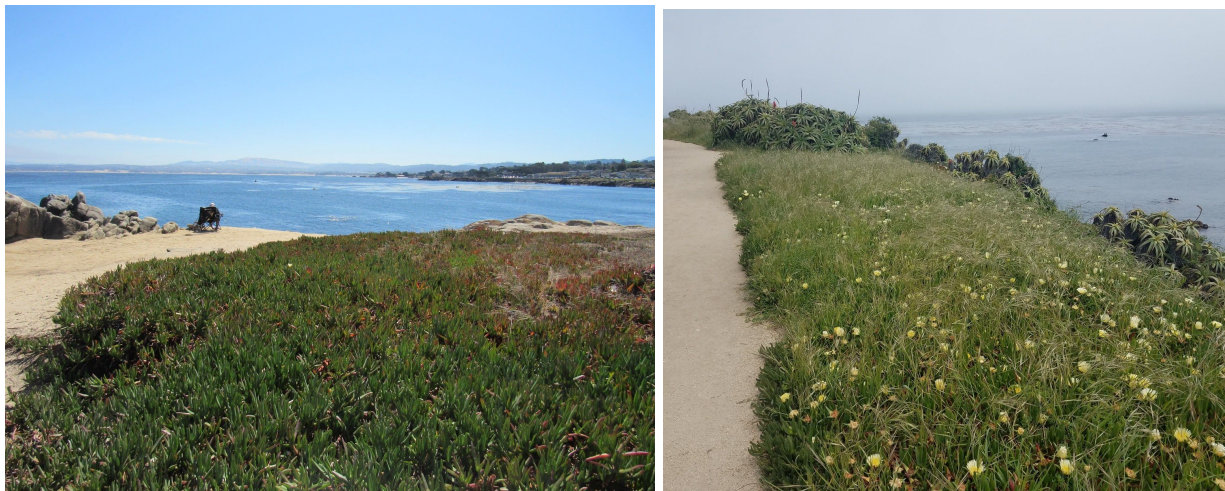
A second species of ice plant is also present within Perkins Park, “Highway” ice plant (*Carpobrotus edulis*), which appears in a few sections of the park. This species is not as desirable as it is considered to be an invasive plant species for the Central Coast region and is being eliminated along stretches of coastline within Pacific Grove, such as at Asilomar Beach and the Point Pinos trail. In addition, it does not contribute to the pink carpet the “Magic Carpet” ice plant provides.

*Above Left “Highway” ice plant at Otter Point.*

*Above Right: “Highway” ice plant and annual grasses along the cliff edge between Sea Palm Ave. and Siren St.*

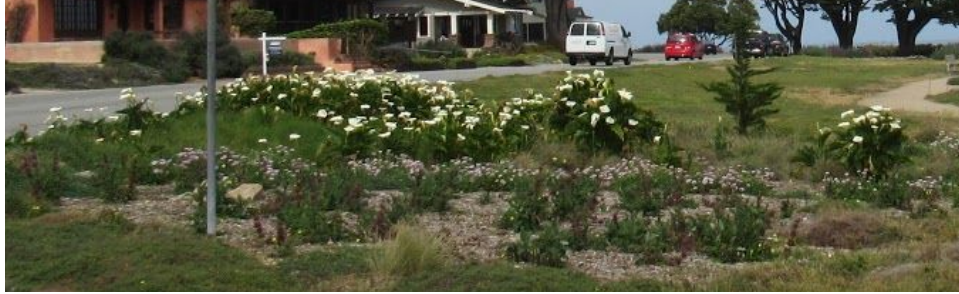
Above: *Calla lilies* at Sea Palm Ave.

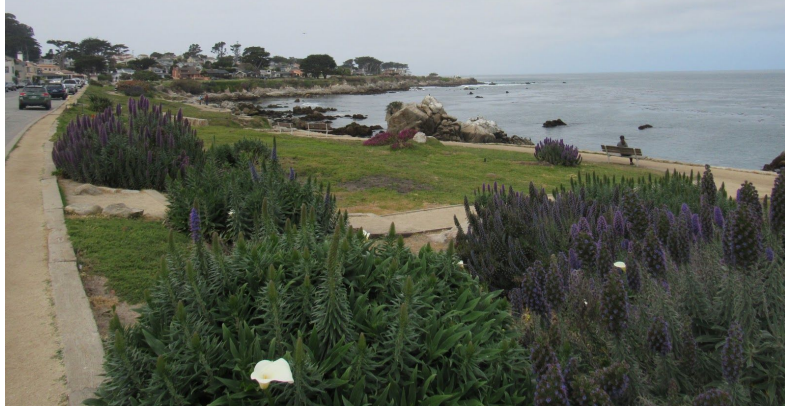
Above: *Pride of Madeira* stands along Ocean View Blvd. near Lover's Point. *Calla lilies* mixed within the stand are in bloom in this photograph.

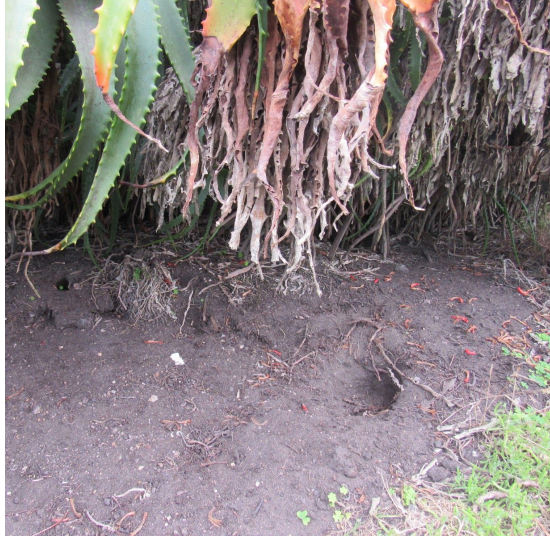
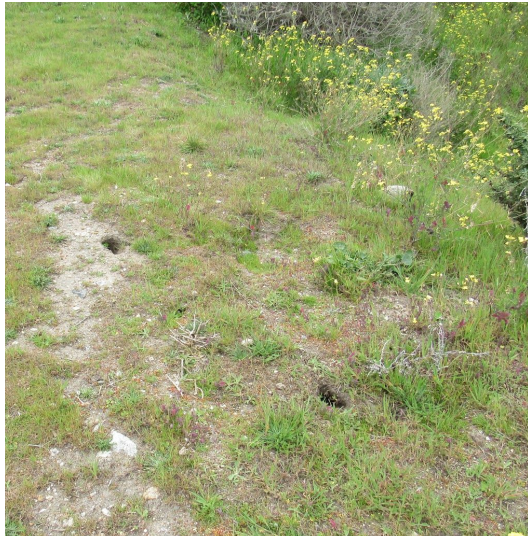
Ground squirrels are a notable pest throughout the park. Ground squirrels can be found along the cliff sides, on rock outcroppings, and within the center of the garden areas. Notably, the ground squirrels use stands of non-native *Aloe arborescens* as their main nesting ground. They have created burrows beneath the aloes, which have the potential to destabilize the plant and cliff sides they reside upon.

*Above Left: A ground squirrel hole beneath an aloe on the south side of Perkins Park near Lover's Point.  
Above Right: Ground squirrel holes within garden space in Perkins Park near Sea Palm Ave.*

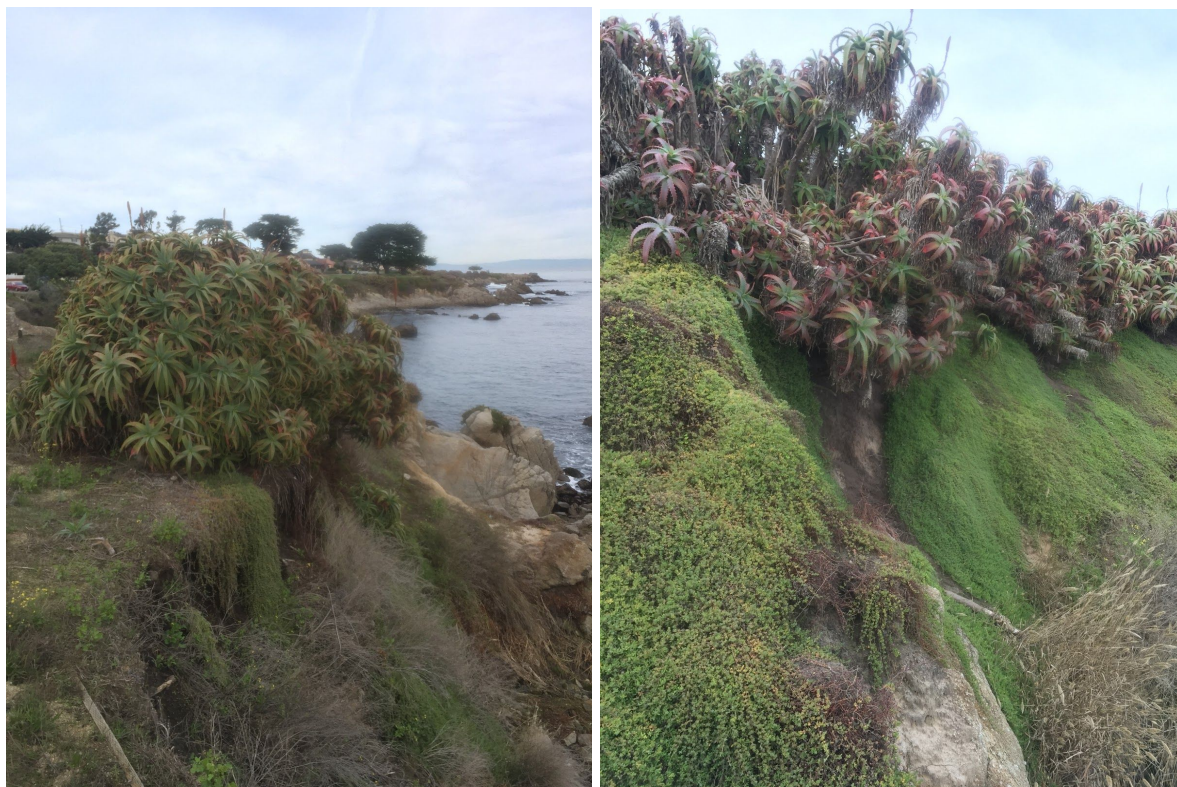
Erosion is a concern with the aloes located along the cliffsides. Further investigations will be required to determine if their sheer size and weight has the potential to cause a catastrophic or exasperated erosion event of the cliffside.

*Above Left & Right: Aloes precariously perched along the cliff edge near Sea Palm Ave.*

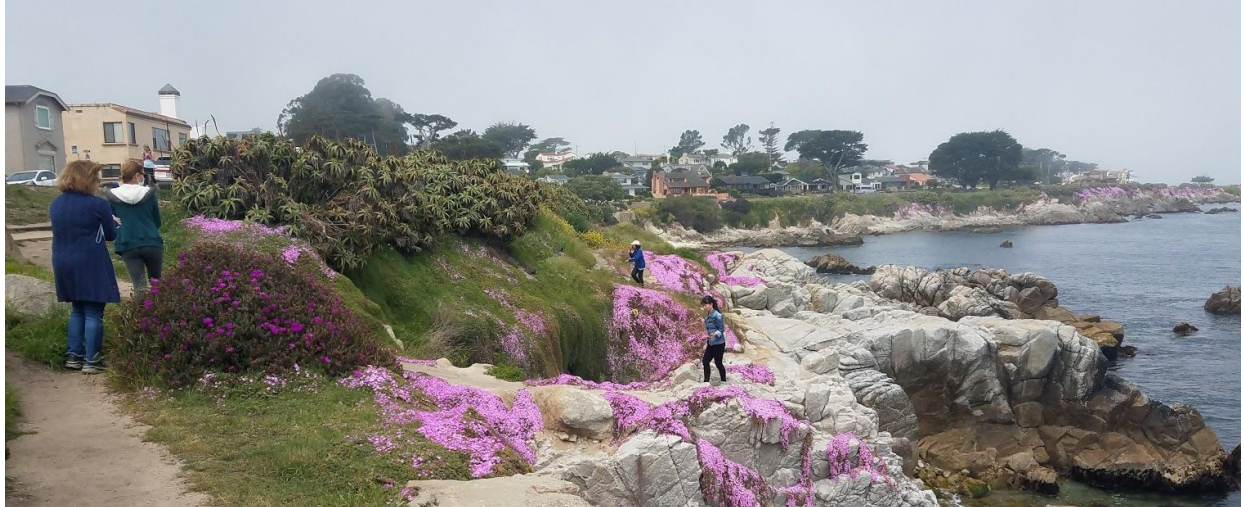
*Above: Aloes are beginning to fall off the cliff edge near Lover's Point.*

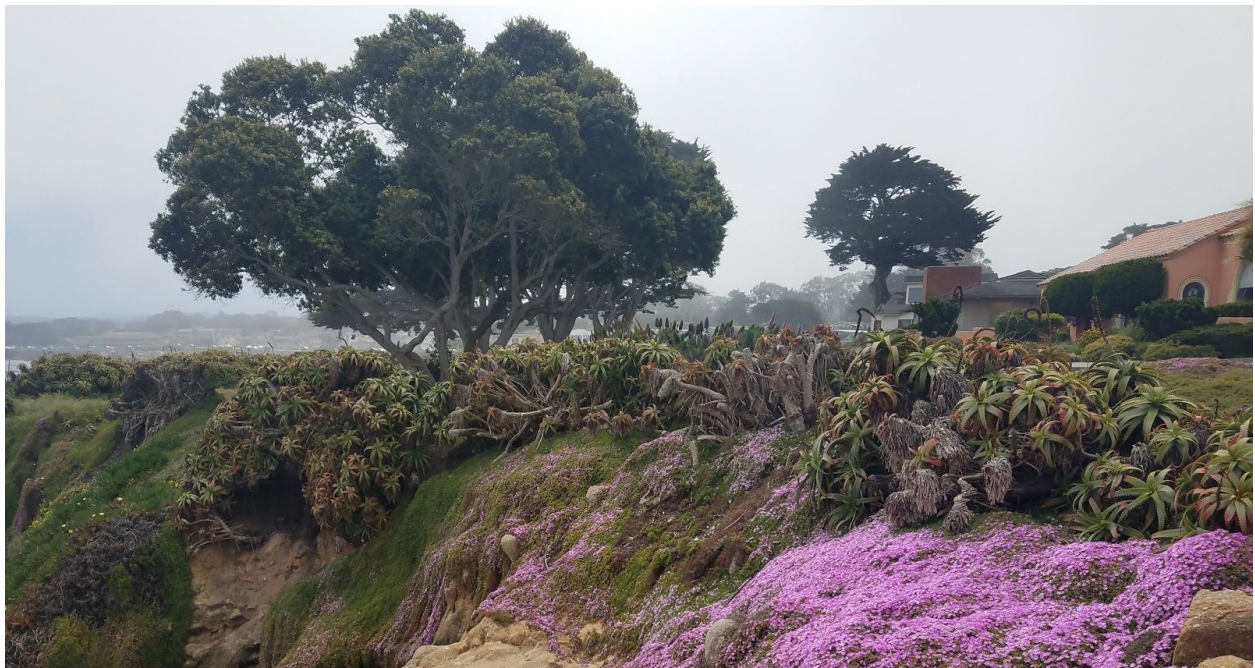
*Above: Aloes at risk of falling off the cliff edge near Siren St. Four plants showing signs of die-off.*

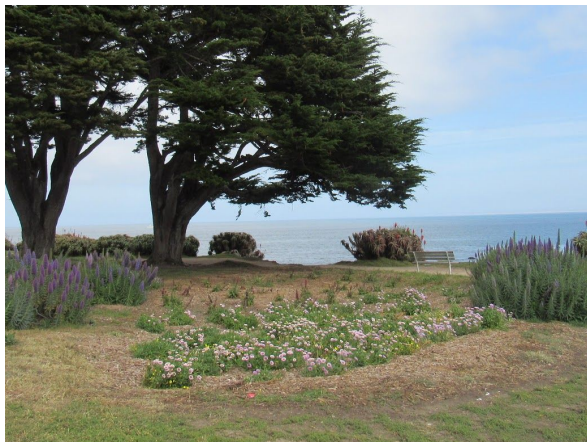
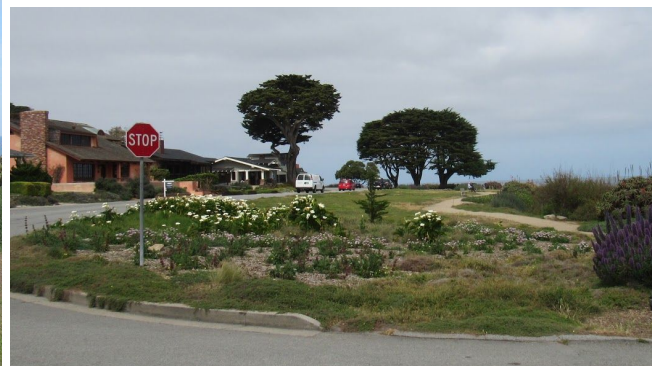
Additional native habitat is likely to form in two areas that have been recently planted with native species, at Sea Palm Ave. and near Siren St. below the Cypress trees. The **CONDITION** of these gardens is "Healthy and Thriving." However, there are currently large gaps between plants where weeds can easily grow. In addition, they are laid out in a linear pattern in monoculture rows, which may be aesthetically pleasing but does not mimic natural habitat patterns.

*Above Left: Native plant garden near Siren St. Seaside daisy (Erigeron glaucus) in full bloom in March 2020.*

*Above Right: Native plant garden at Sea Palm Ave. with Salvia sp. in bloom.*

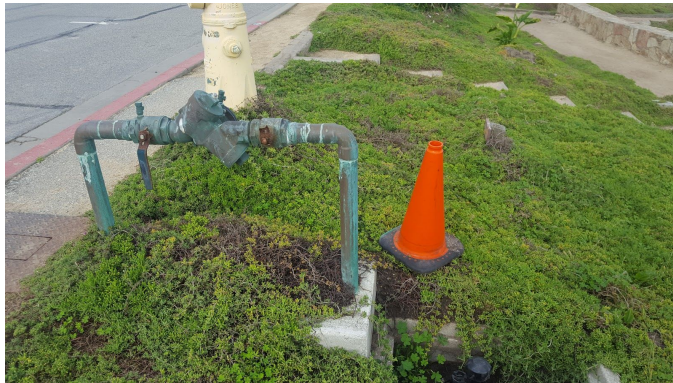
The existing water meters appear to be in working order. The existing copper backflow devices appear to be of the correct size and in working order, however, they are very weathered. The existing backflow devices are mounted upon concrete blocks that have been subject to major erosion, thus making them vulnerable to damage (see images below). The historic water use for Perkins Park is currently unknown.

*Backflow device located between Lover's Point and Sea Palm Ave.*

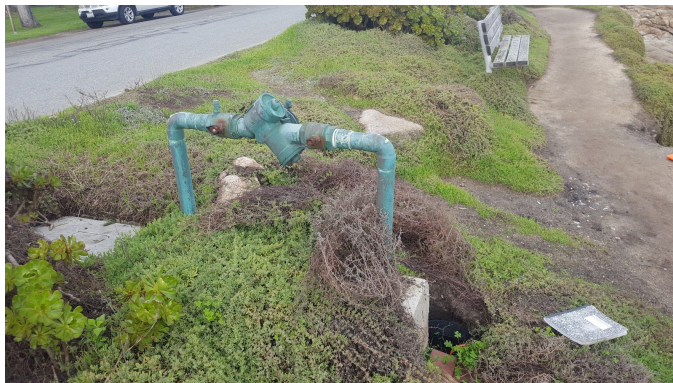
*Backflow and valve box located between Esplanade Park and Otter Point exhibiting erosion.*

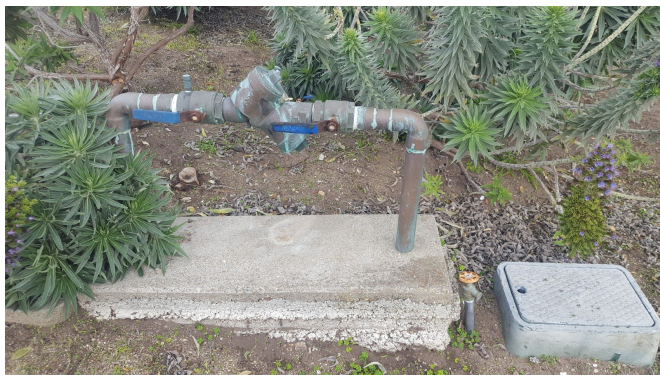
*Backflow device and valve box near Otter Point.*

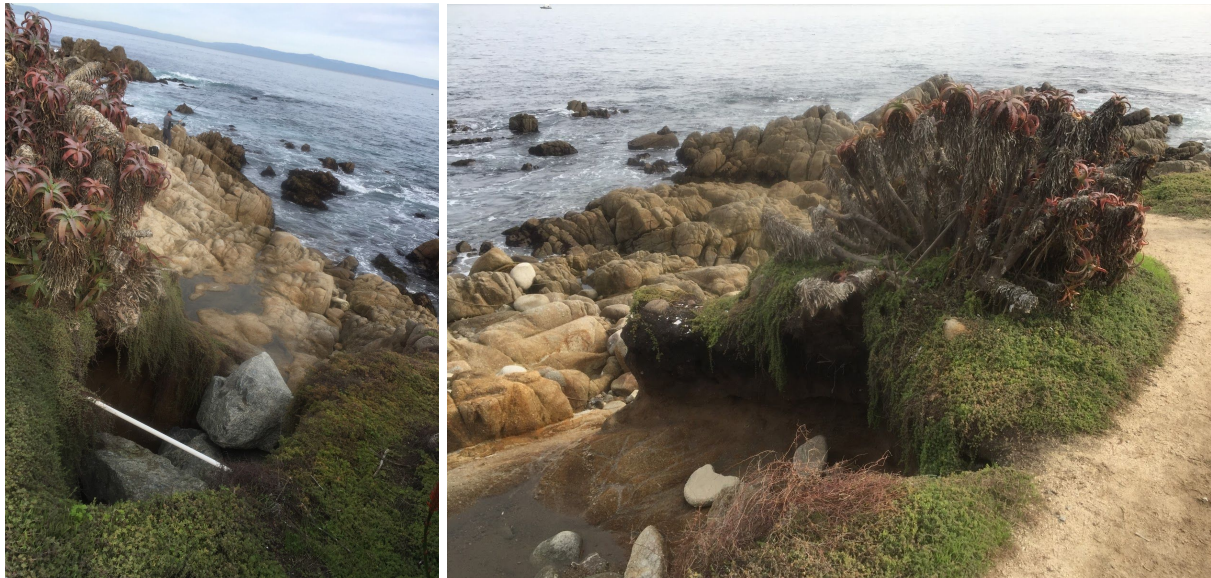
*Above: Erosion of soil along the cliffside exposes a broken irrigation line, creating a large hazard.*

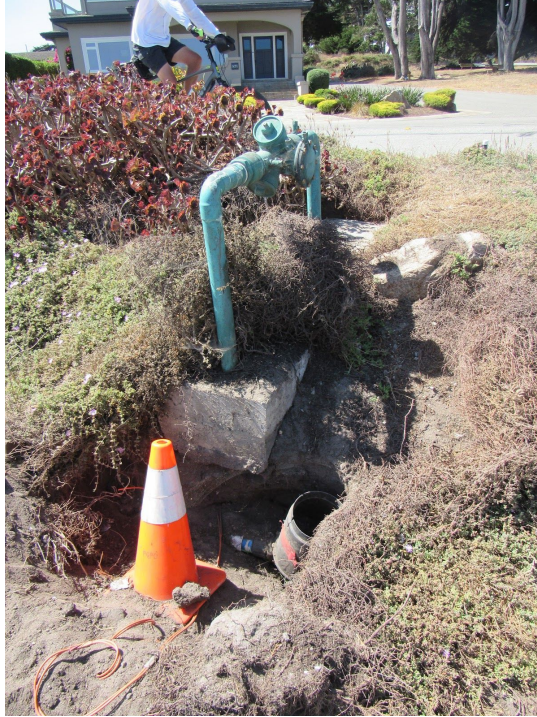
*Above Left: A leaking irrigation line is most likely the culprit for the erosion we see around the backflow devices throughout the park.*

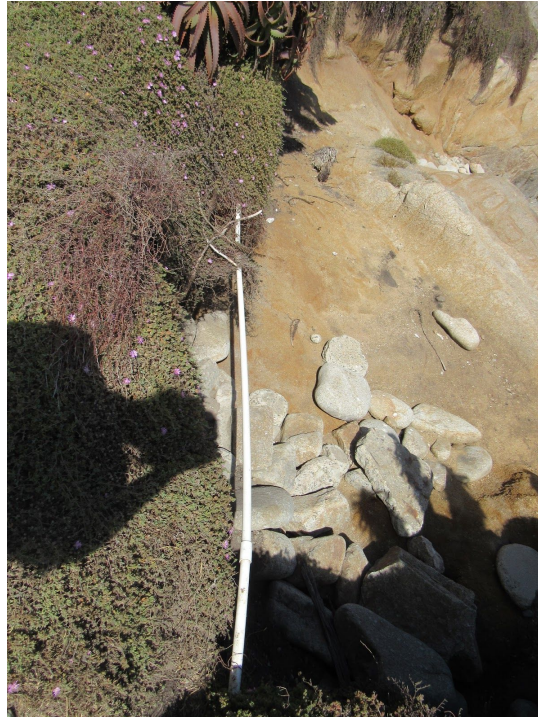
*Above Right: Area of the park where the cliffside is being eroded away and has exposed the irrigation line.*

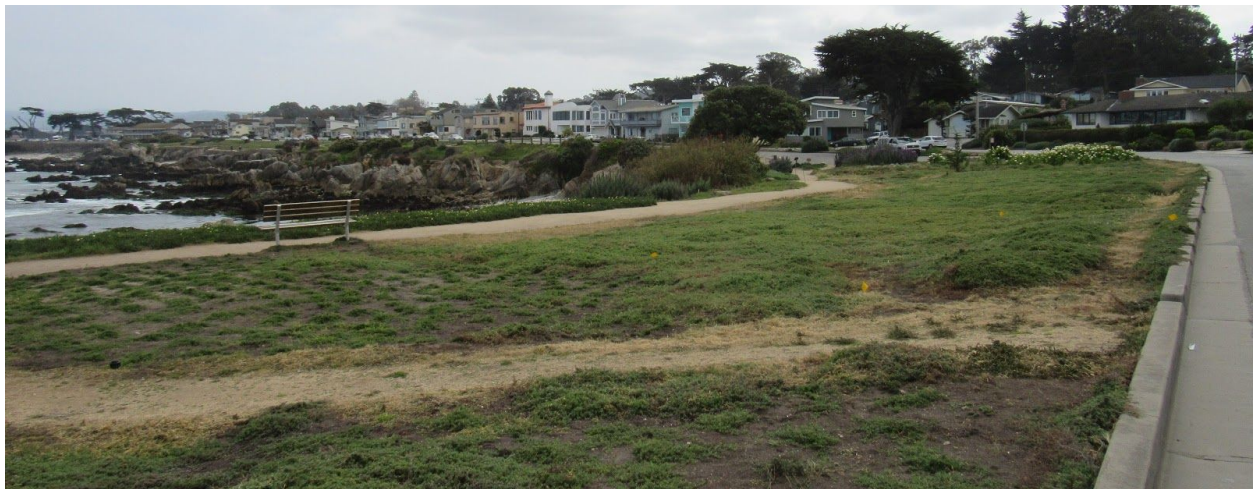
*Above: A curb cut and pedestrian path along Ocean View Blvd. Compacted soils due to human trampling will increase water flows and soil erosion.*
