## Chautauqua Hall

### Building Assessment

162 16th Street, Pacific Grove, California 93950

### FINAL

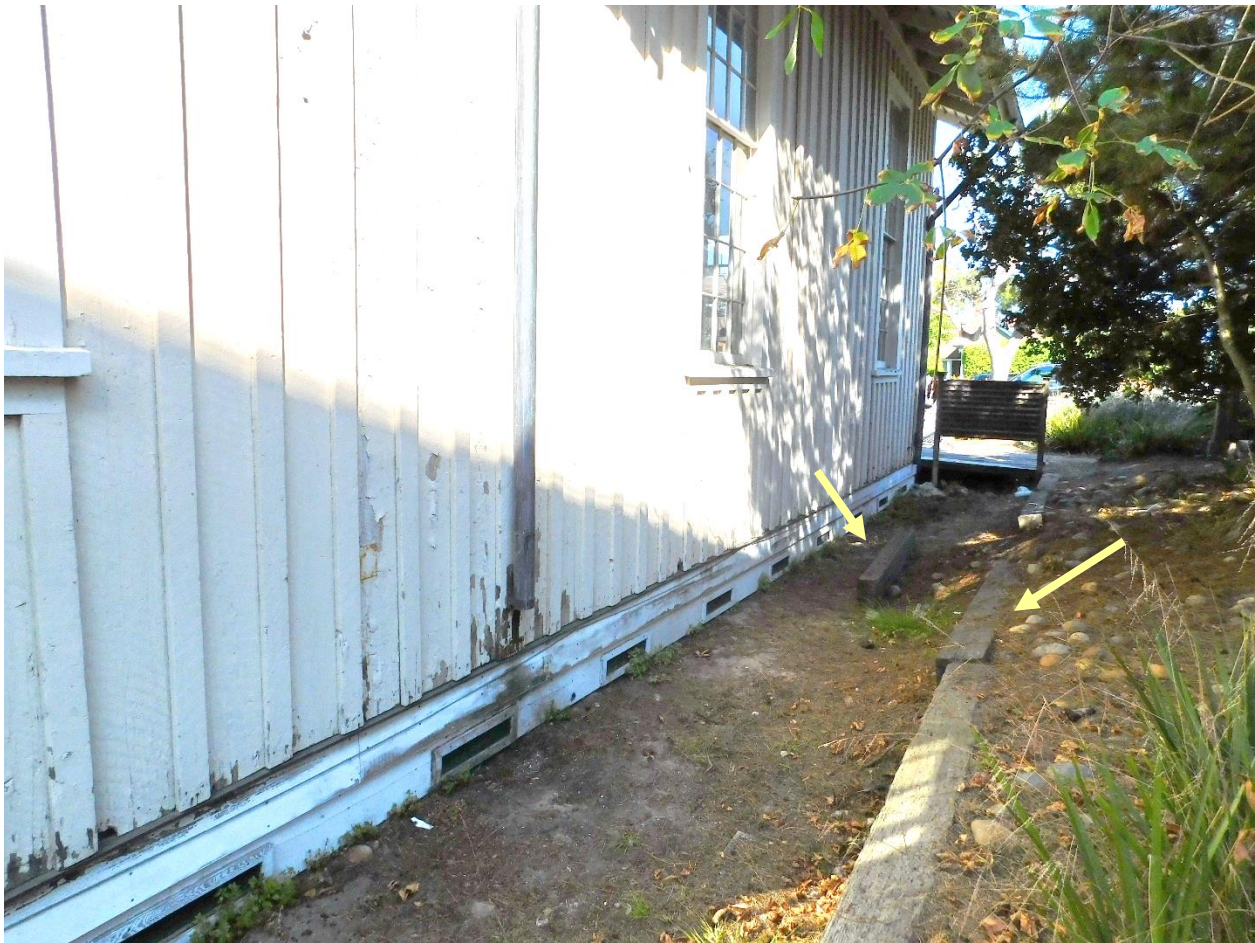
- The site appears to slope down to the south face the building.
- One of the retaining wall timbers has rotated inward and another is displaced (Figure 6).

Figure 6. View of the short retaining wall along the south facade of the main hall. Note also the rotated and displaced retaining wall timbers (arrows).

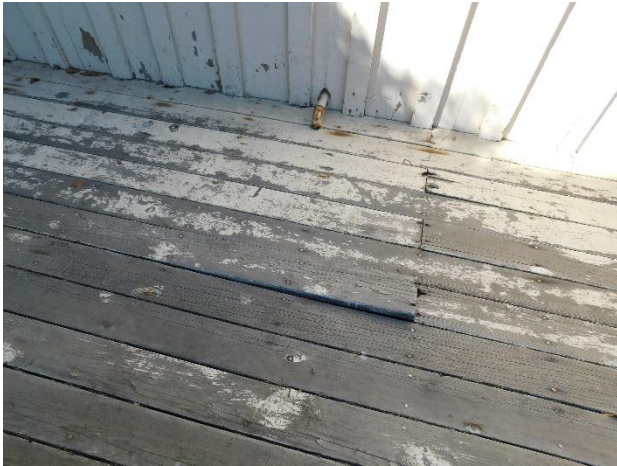
- There are many loose nails and wood boards on the east and south decks that create tripping hazards. The south deck has especially loose/unsupported and severely weathered deck boards creating more dangerous tripping and egress hazards (Figure 16 and Figure 17).

Figure 16. Loose deck board at the south deck.

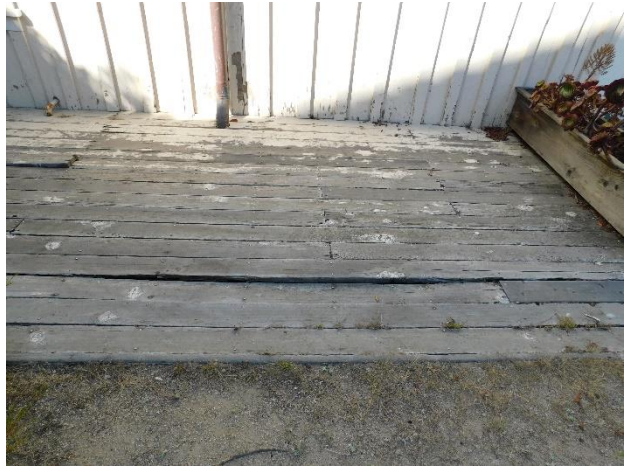
Figure 17. Sagging deck boards at the south deck.

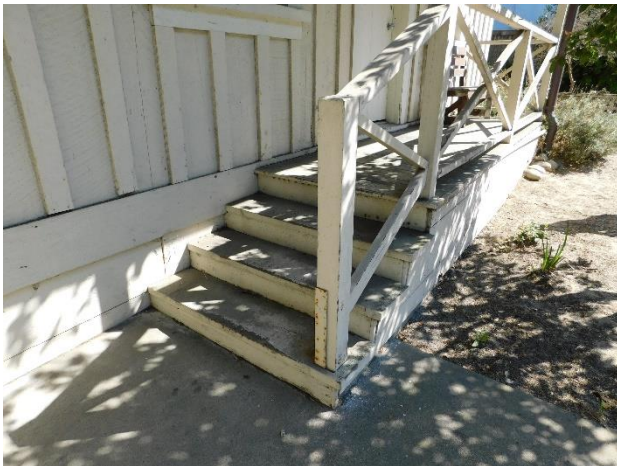
- There is a loose guardrail post at the southernmost west porch, which creates a potential falling hazard (Figure 18).
- There is loose, missing, or peeling paint at painted wood elements (Figure 19). There is significant paint loss on the east and south decks.

Figure 18. Porch with loose guard rail post.

- The design of the guardrails at the west porches and north stair and landing do not meet the (current) 2022 California Building Code (CBC) requirements. We expect this includes both dimensional configuration requirements and structural loading requirements. However, the California Historical Building Code (CHBC) allows for them to remain at “their historical height and spacing unless a distinct hazard has been identified or created by a change in use or occupancy.”<sup>6</sup>

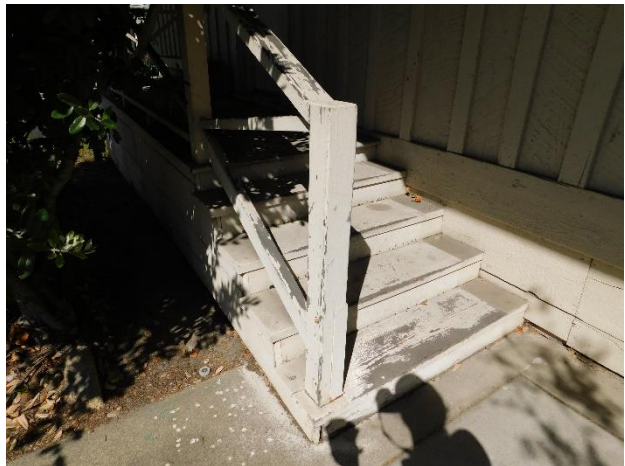
Figure 19. Example of loose, flaking, and missing paint at painted wood elements, including walking surfaces.

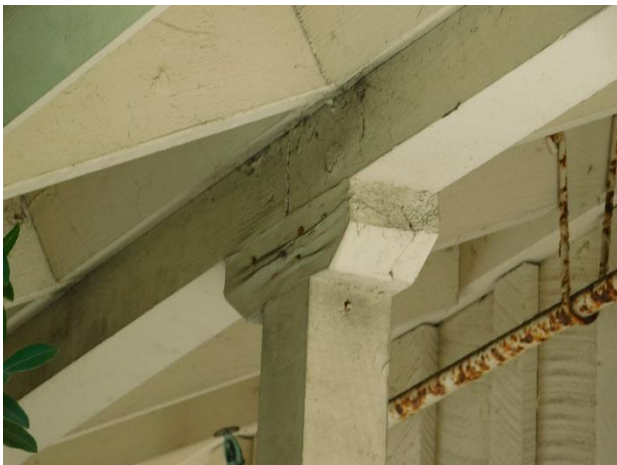
- One of the corbels at the top of a post supporting the shed roof over the deck has evidence of localized crushing (Figure 20). The cause could not be determined. WJE probed the wood and did not detect soft material typically found at decayed wood.

Figure 20. Crushing at corbel at west porch.

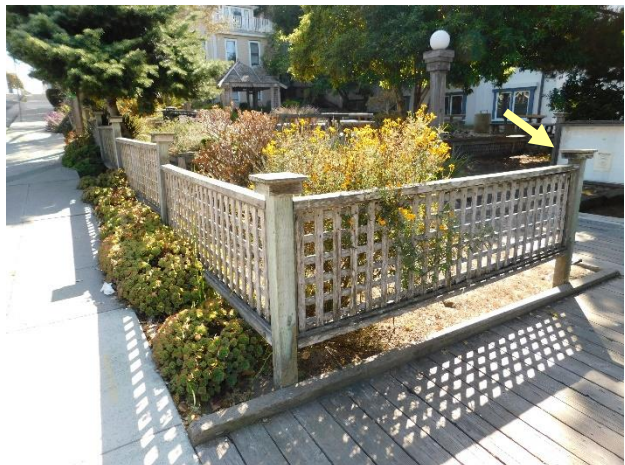
- A wood garden fence along the south edge of the east deck has a loose post (Figure 21).
- There is loose skirting trim at the southernmost west porch (Figure 22).

Figure 21. Loose garden wall post (arrow).

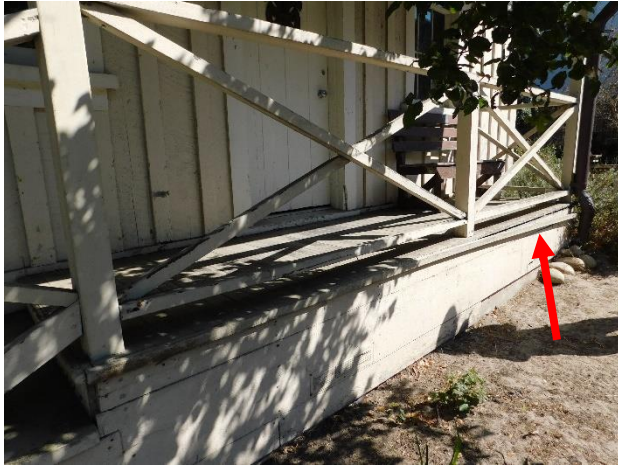
Figure 22. Loose skirting trim at a west porch (arrow).

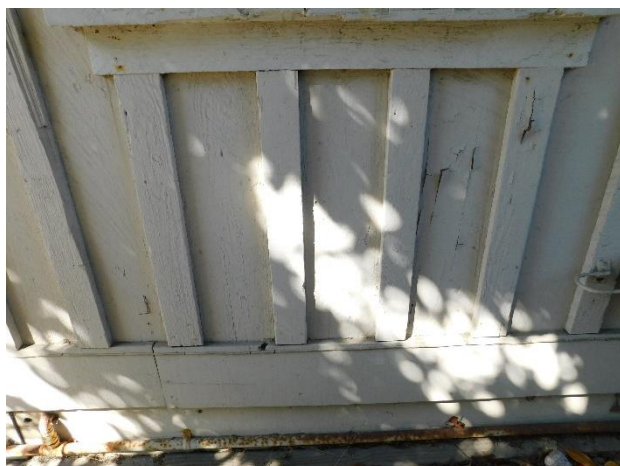
Figure 25. No metal flashing at water table along south facade of ancillary spaces (line near top of water table trim is a small wire). Also note the loose and peeling paint.

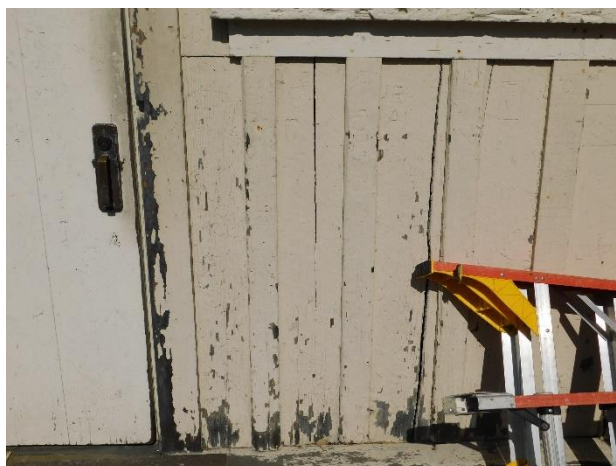
Figure 26. Example of weathered and peeling paint typical throughout the cladding. Also note the splitting boards.

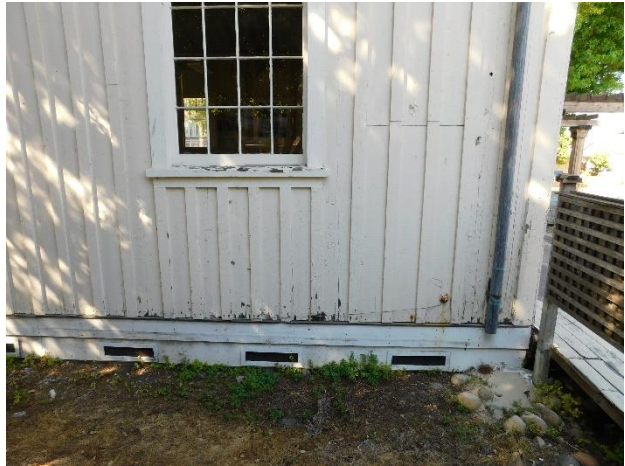
Figure 28. Example of deteriorating board and batten cladding at base of the wall.

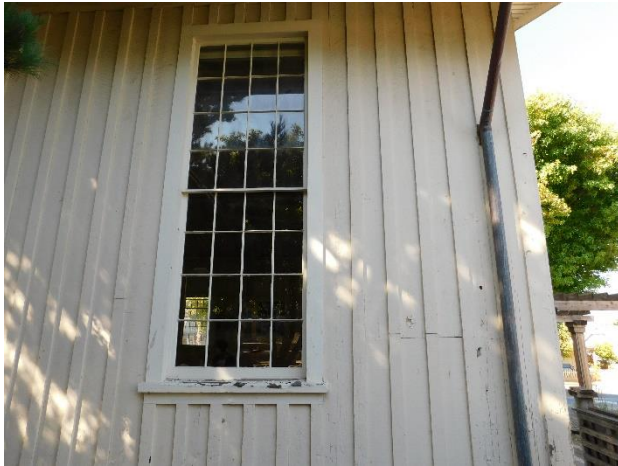
- At the south windows of the main hall:
  - Sashes are in serviceable condition, including intact paint and glazing putty at the sashes (Figure 33).
  - Window sills have missing, weathered, and peeling paint (Figure 33).
- At all other windows:
  - Missing, weathered, and peeling paint is common, especially at window sills and bottom rails of window sashes (Figure 34).
  - Isolated areas of soft, deteriorated wood at window sills (Figure 35).
  - Isolated areas of damaged window sashes (Figure 36).
  - Isolated areas of damaged or missing muntins (Figure 37).
  - Missing or cracked glazing putty is common (Figure 37).
  - Isolated areas of cracked or damaged glass lites (Figure 38).

Figure 33. A south window of the main hall in serviceable condition with peeling paint at sills.

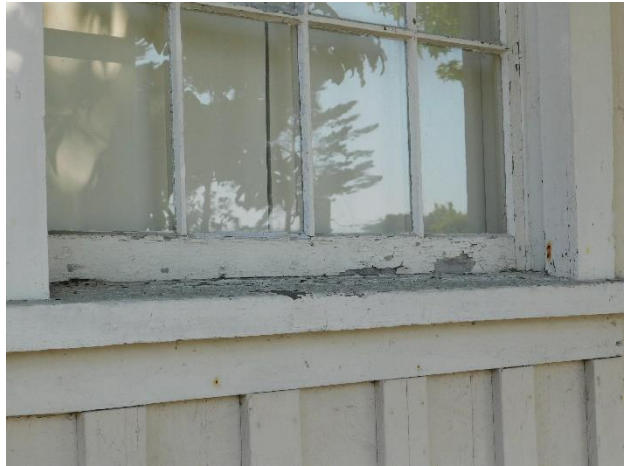
Figure 34. Deterioration and peeling paint at bottom rails of sashes and at window sills.

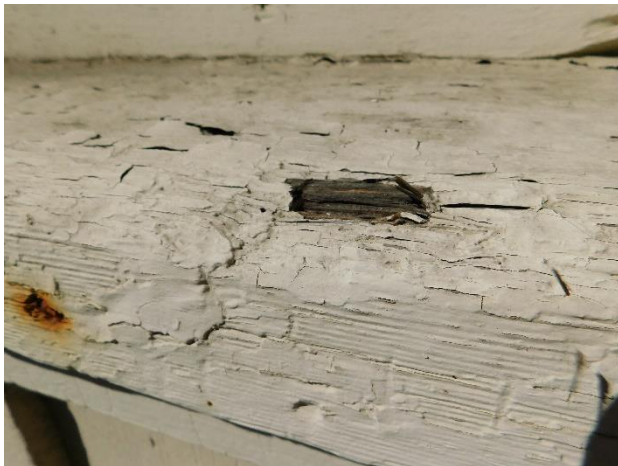
Figure 35. Example of isolated areas of wood deterioration at wood sills.

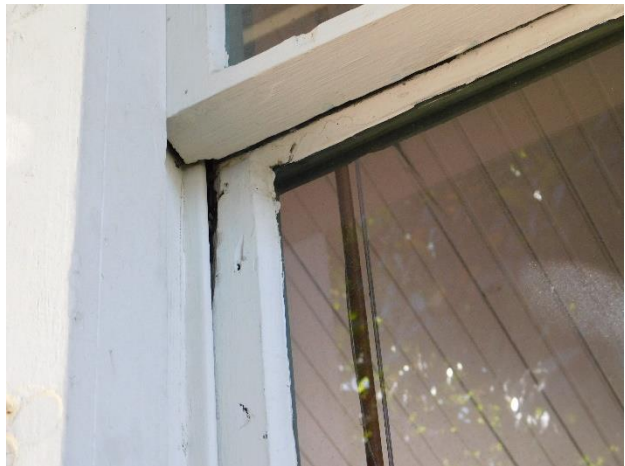
Figure 36. Example of damaged window sash.

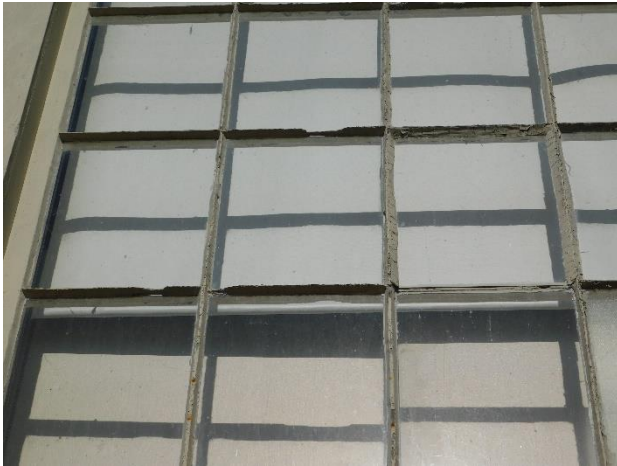
Figure 37. Example of damaged or missing muntins. Note also the cracked and missing glazing putty.

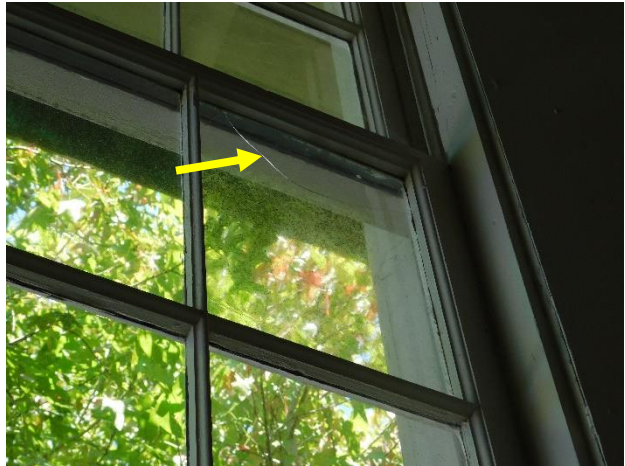
Figure 38. Example of cracked window lite (arrow).

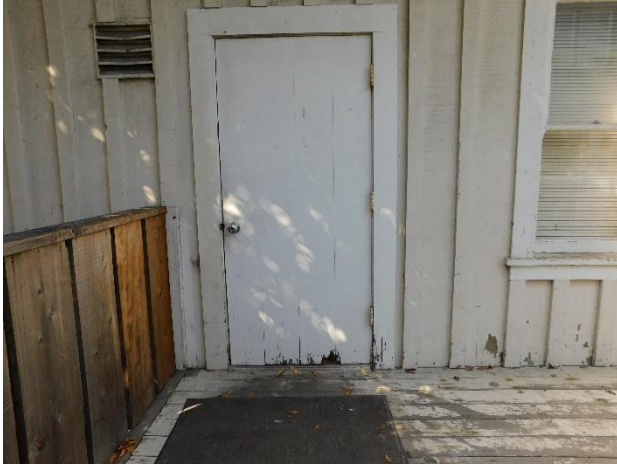
- Missing, weathered, and peeling paint is typical, especially at the bottom of door leaves (Figure 43).
- Areas of soft, deteriorated wood at the bottom of door leaves are typical to exterior doors (Figure 43).
- There is a large visible gap between the double leaf exit doors of the main hall on the south facade (Figure 44). There is no astragal between the doors and daylight is visible through the large gap. This condition can allow air loss and wind-driven rain into the interior spaces of the main hall.
- The large double leaf doors on the east facade (Figure 39) have isolated areas of splitting tongue-and-groove beadboard that have been previously repaired with sealant (Figure 45). The astragal between the doors is partially damaged and daylight is visible between door leaves, which can allow air loss and can allow wind-driven rain into the interior spaces of the main hall.

Figure 43. Deteriorated paint and wood boards at the bottom of an exterior wood door.

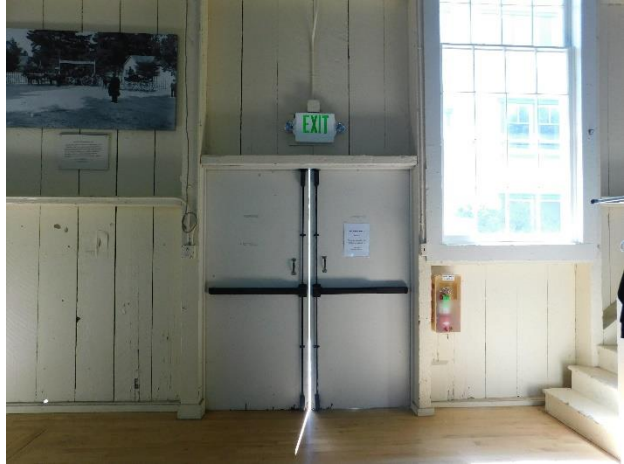
Figure 44. Daylight between a double-leaf door in the main hall.

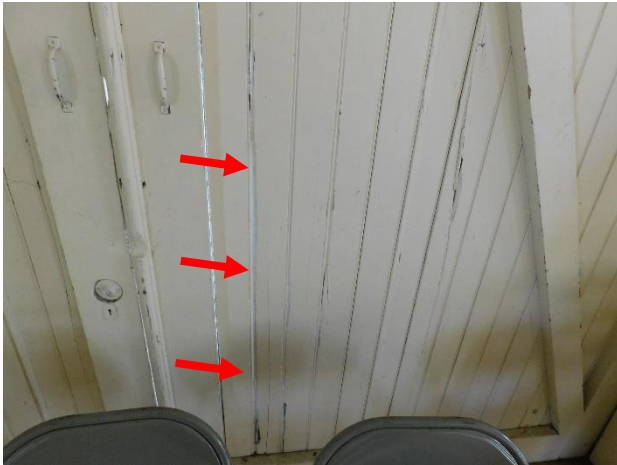
Figure 45. Previous sealant repairs at the large-double leaf doors on the east facade. Also note the daylight visible between the stile and the bead boards.

- Sealing splits in boards with sealant, like that observed at the large double-leaf doors of the east facade is not a durable repair. However, if paintable sealant is used to seal splits in individual wood boards, it can help reduce air leakage and wind-driven rain infiltration without impacting the historic integrity of the building.

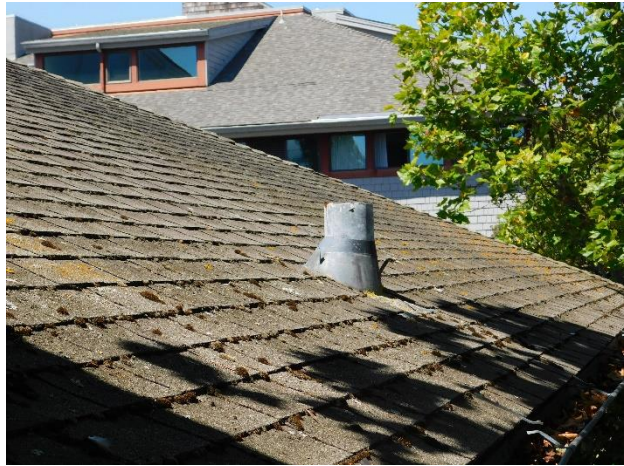
- The areas of shingles observed are generally in serviceable condition, with signs of minor weathering and biological growth.
  - There is greater biological growth on the north side of the roof of the ancillary rooms and at shaded areas of the roofs (Figure 51).

- One of the large roof vents is missing a cap which exposes it to infiltration from water and debris (Figure 51).

Figure 51. Biological growth seen at shaded areas of the roof and a missing cap over the large vent.

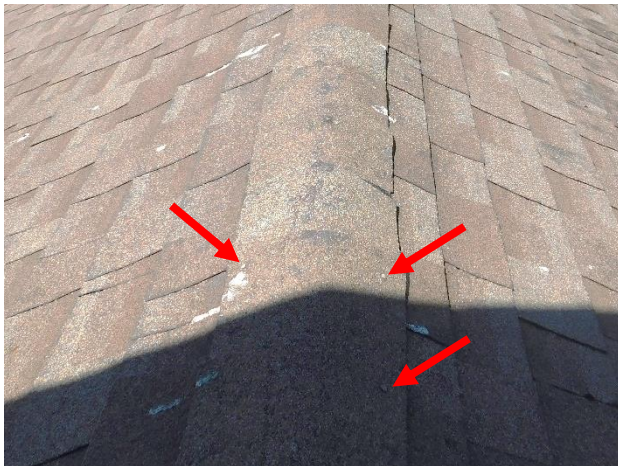
Figure 52. Exposed fasteners (arrows) and unfavorable direction of lap of ridge shingles at roof over ancillary spaces.

- Exposed and unsealed fasteners through roofing can lead to water intrusion into the roof assembly and resulting deterioration and damage. This includes roof shingle fasteners, gutter fasteners, etc.
  - Asphalt shingle roof nails should be concealed by the overlying shingle, including ridge shingles. At the last ridge or hip shingle of a run, the shingle should be set in roofing cement and exposed fasteners sealed with elastomeric sealant.<sup>7</sup>
- Ridge shingles should be installed so that they lap away from prevailing winds.<sup>8</sup> Unsealed or exposed fasteners can lead to water intrusion into the roof assembly. Shingles lapped towards prevailing winds can also lead to water intrusion or even failure from wind uplift.

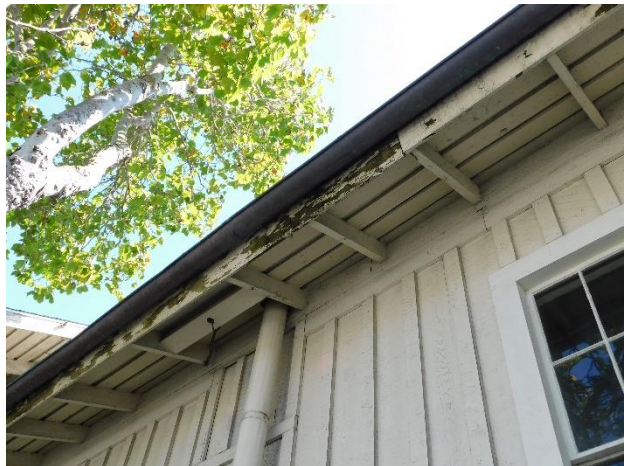
- Missing, weathered, and peeling paint is common at wood facia, barge boards, and exposed roof sheathing and framing (Figure 53).
- Gutters have several observed conditions:

Figure 53. Example of loose and missing paint at roof framing.

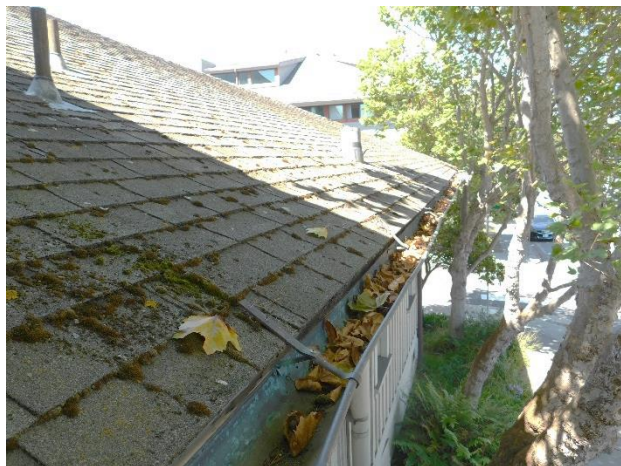
Figure 54. Debris collecting in gutters, exposed and loose fasteners, and bent gutter spacers.

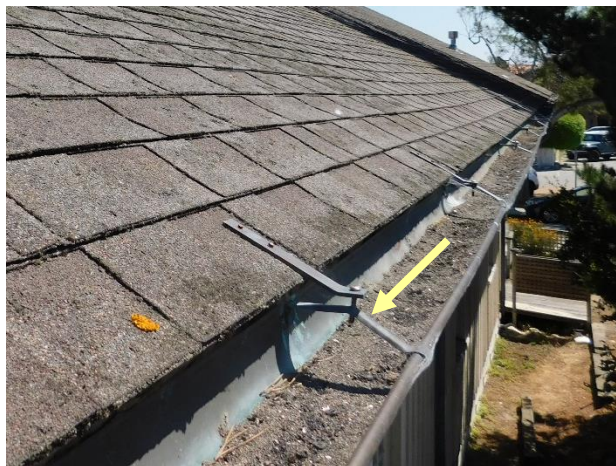
Figure 55. Exposed gutter strap fasteners through roofing and bent gutter spacers (arrow).

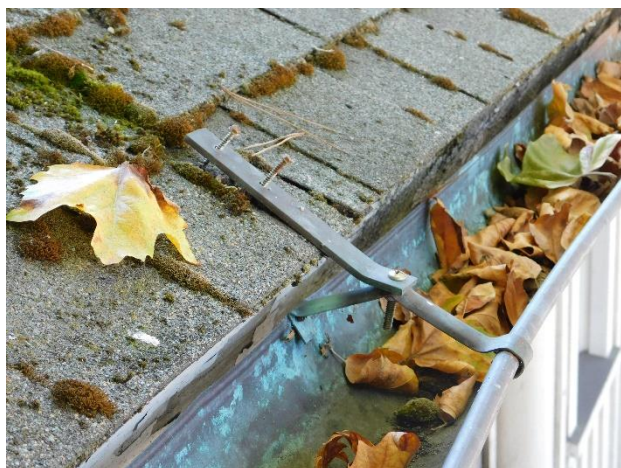
- There are isolated areas of loose, bent, or detached gutter straps (Figure 56). The gutter straps appear to be fastened to gutter spacers that are not designed with the appropriate thickness, as evident by several bent spacers.

Figure 56. Example of loose gutter strap and bent spacer.

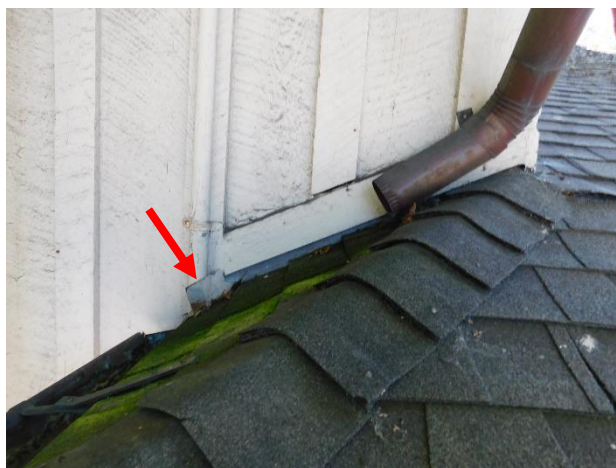
Figure 57. Sidewall flashing with kick-out (arrow) at north wall of main hall. Also note the exposed roofing nails at the hip shingles.

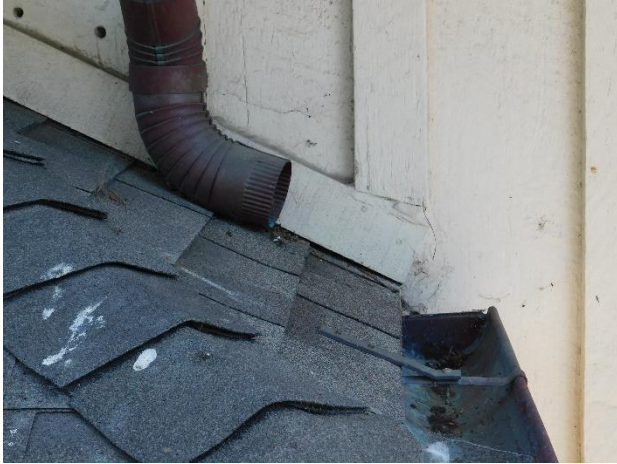
Figure 58. Missing kickout flashing at south wall of main hall. Also note the exposed roofing nails at the hip shingles.

- The absence of sidewall flashing with a kick-out increases risk of water infiltration and resulting deterioration of materials at the vulnerable sidewall-to-roof transition.

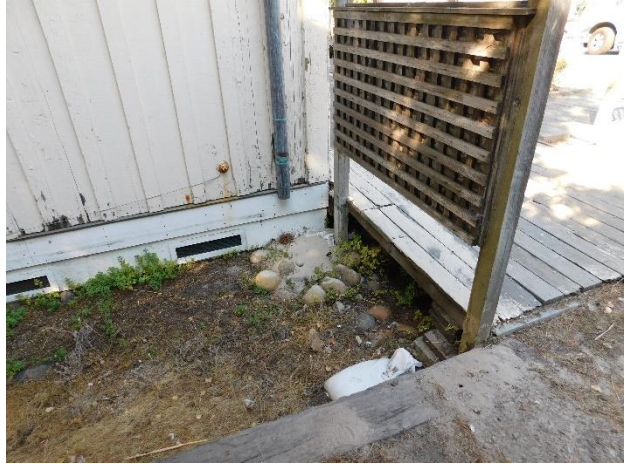
- Most of the leaders discharge water directly adjacent to the building's perimeter without directing it away from the building. In some locations, lower sections of leaders may be missing and they terminate a foot or two above grade and expose the building wall to rainwater discharge (Figure 59 and Figure 60).

Figure 59. Example of typical rain leader discharging adjacent to the building and its foundation.

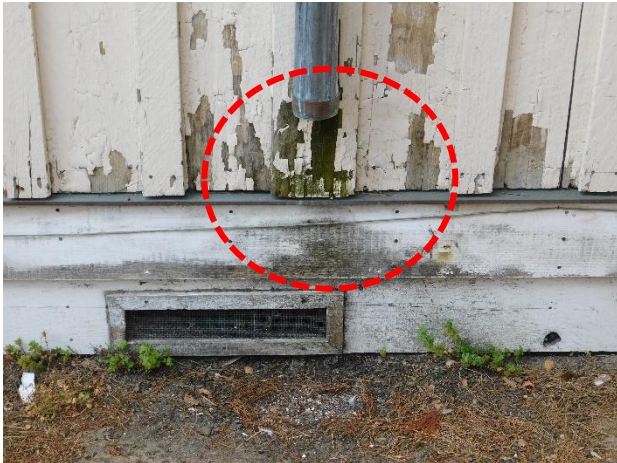
Figure 60. Example of a rain leader discharging high above grade. Note the greater amount of biological growth, wood deterioration, and paint loss around this area (dashed red line).

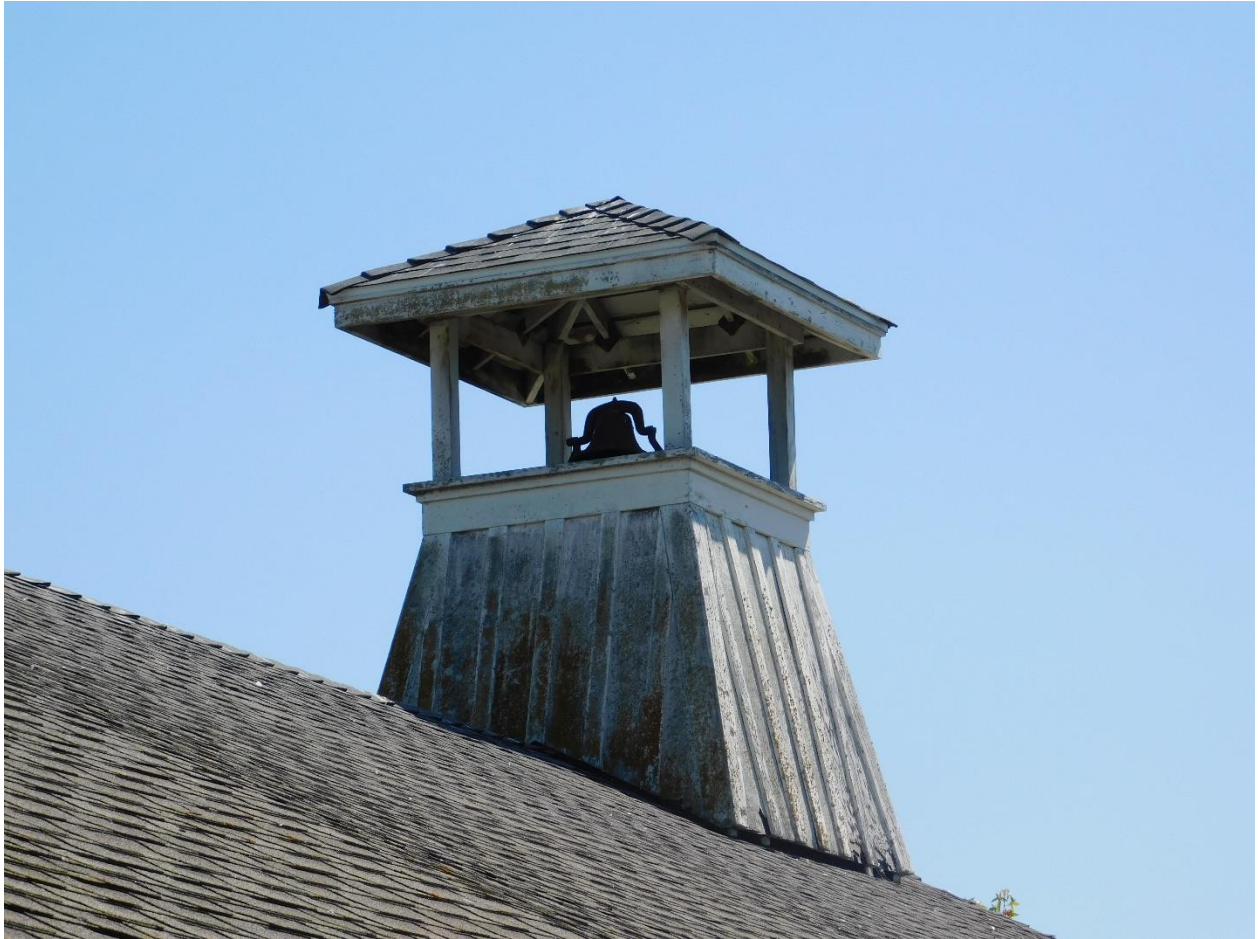
- There is missing, weathered, and peeling paint at cladding, fascia, and exposed roof sheathing and framing (Figure 62).
- There is significant biological growth on the wood elements of the belfry (Figure 61).

Figure 61. View of the belfry from the southwest. Note the significant biological growth on the west facade.

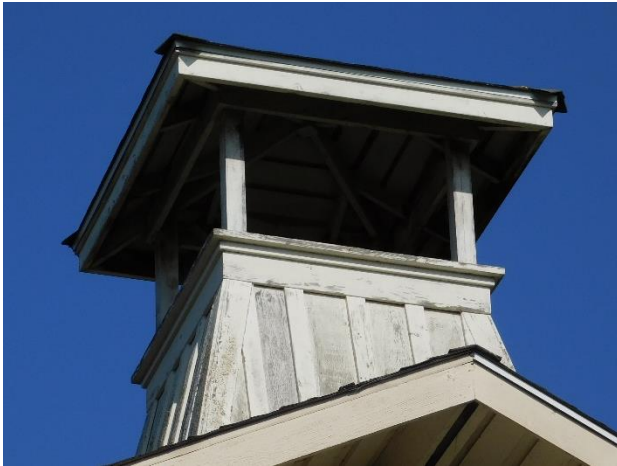
Figure 62. Detail view of missing, weathered, and peeling paint.

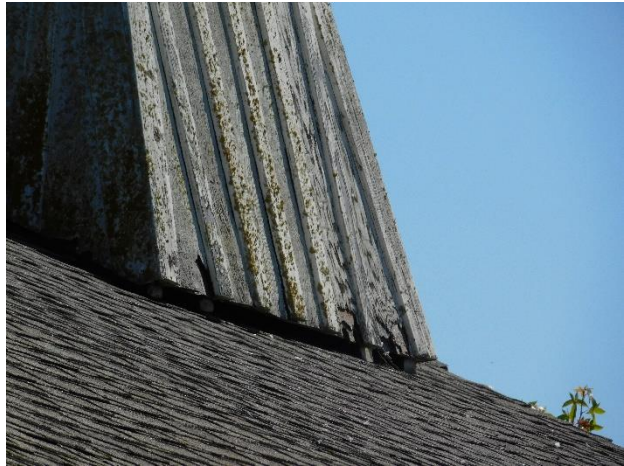
- There is wood deterioration at the base of the belfry (Figure 63).

Figure 63. Detail view of deterioration at the base of the belfry.

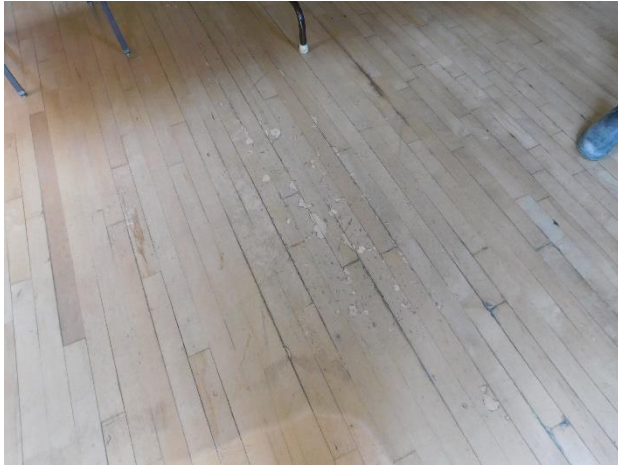
- There are isolated areas of deteriorated floor finish in the main hall near the primary entrance on the east facade. (Figure 79)
- The access hatch to the crawlspace beneath the main hall has been sealed shut. Access to the crawlspace of the main hall is limited to an exterior hatch on the north facade of the ancillary spaces.
- The exposed framing and sheathing in the mezzanine level have isolated areas of water staining, indicative of water intrusion (Figure 80).

Figure 79. Peeling floor finish in the main hall.

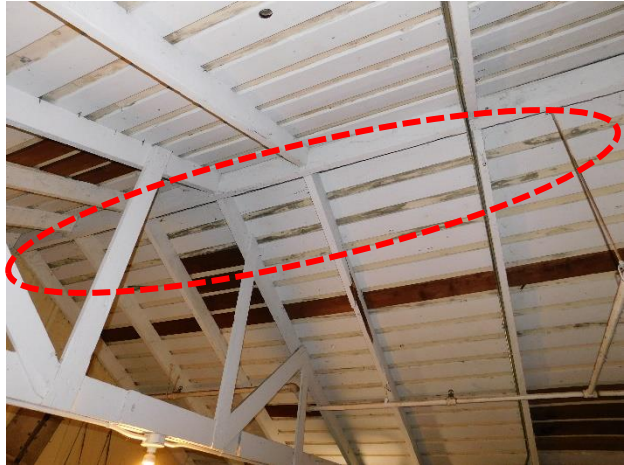
Figure 80. Staining at roof in the mezzanine.

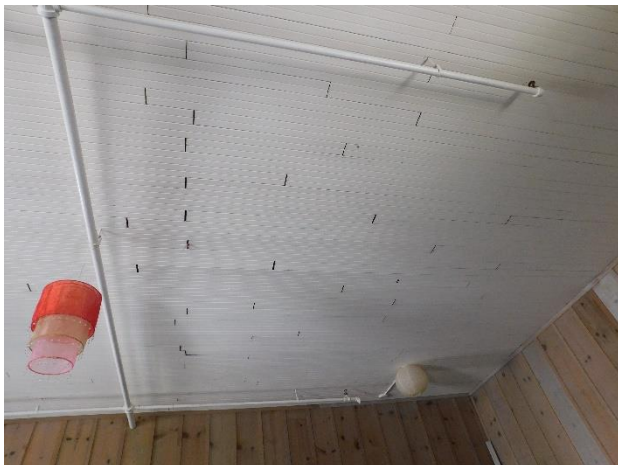
- There are gaps between ends of boards throughout the ceiling of the northwest and southwest multipurpose rooms (Figure 81 and Figure 82). The ceiling of the northwest multipurpose room exhibits the largest gaps.
- There is a small area of water staining at an abandoned ceiling penetration in the northwest multipurpose room that is indicative of water intrusion (Figure 83).

Figure 81. Large gaps between ceiling boards in the northwest multipurpose room.

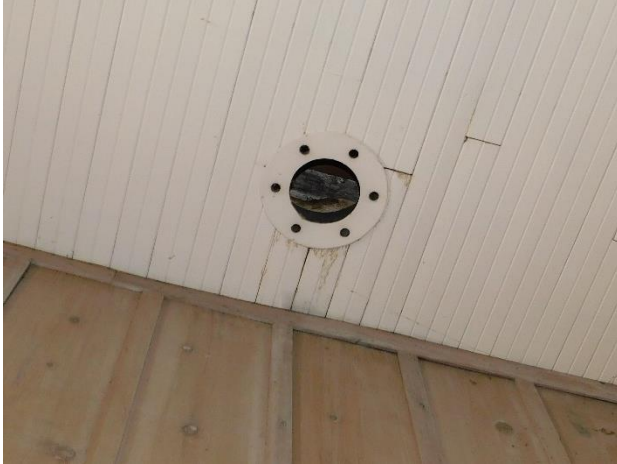
Figure 83. Water staining around abandoned vent in the northwest multipurpose room.

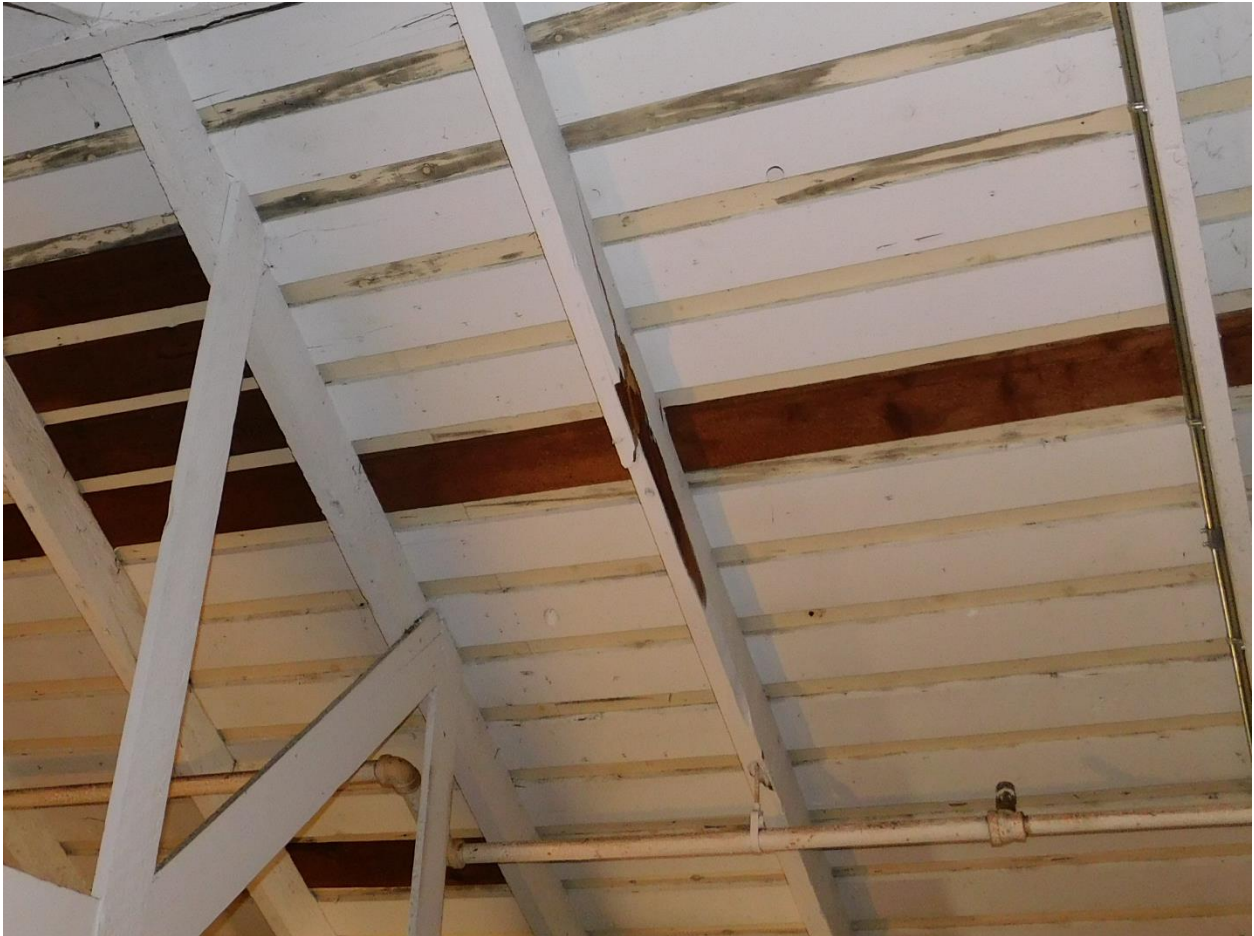
Figure 91. Fractured roof rafter in the main mezzanine.

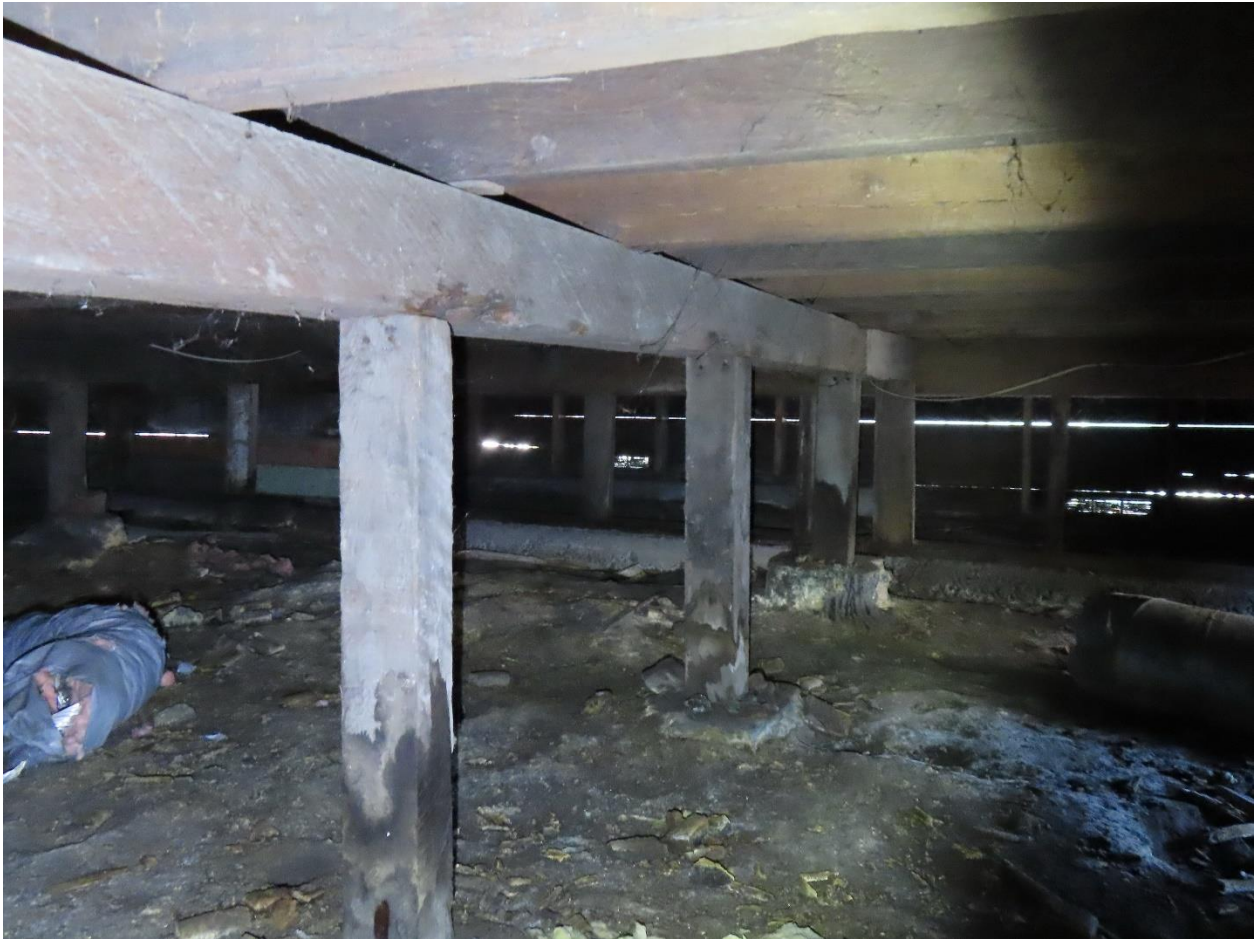
In general, the structural elements of Chautauqua Hall that were observed did not have evident damage or deterioration. No widespread or systematic decay was observed in the roof, wall, or floor framing. One rafter in the mezzanine was observed to be fractured (Figure 91). The conditions in the crawlspace under the building were generally damp and biological growth was present on the soil and some posts, beams, and joists. Several wood posts did not have the code-recommended 8-inch separation from grade (Figure 92).

Figure 92. Water staining and damp soil in the crawl space of Chautauqua Hall.

- WJE suspects the persistent moisture in the crawl spaces may be partly from existing site drainage conditions that are further exacerbated by roof drainage discharging adjacent to the building foundation. While we did not observe obvious signs of wood decay in our limited observations, the conditions observed are conducive to the development of decay, and some may exist already in areas we did not observe.
