# Perkins Park Existing Conditions Report

November 19, 2020 //////////////////////////////////////

**Ecological Concerns, Inc**  
Josh Fodor, Principal  
Rita Manna, Project Manager

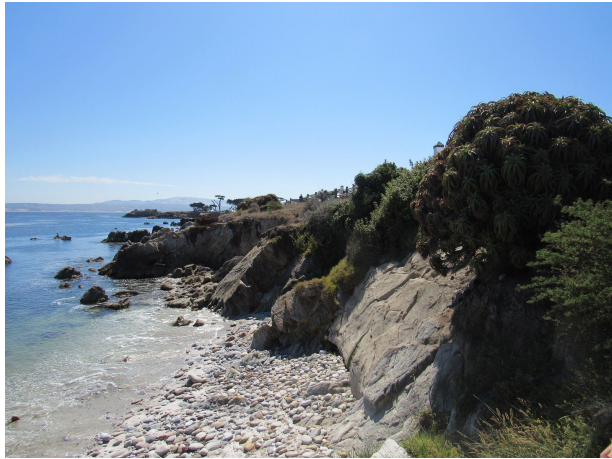
Currently, there is very little native habitat in the park. The cliff-side slope along the shoreline opposite Sea Palm Ave. is the only area containing predominantly native California coastal bluff plants.

*Above Left: Looking south along the cliff bluff from the stairs at Sea Palm Ave.*

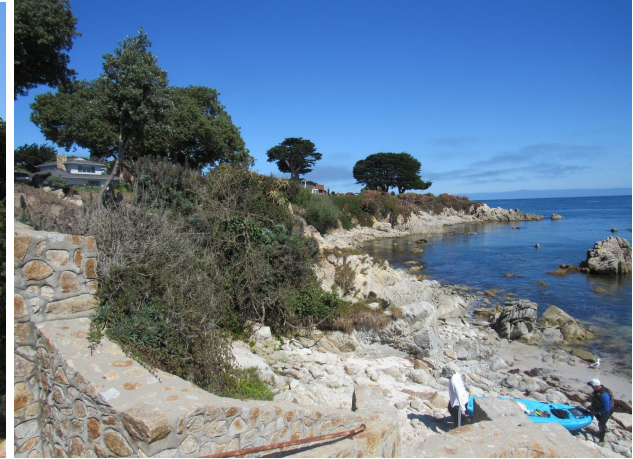
*Above Right: Looking north along the cliff bluff from the stairs at Sea Palm Ave.*
