## Chautauqua Hall

### Building Assessment

162 16th Street, Pacific Grove, California 93950

### FINAL

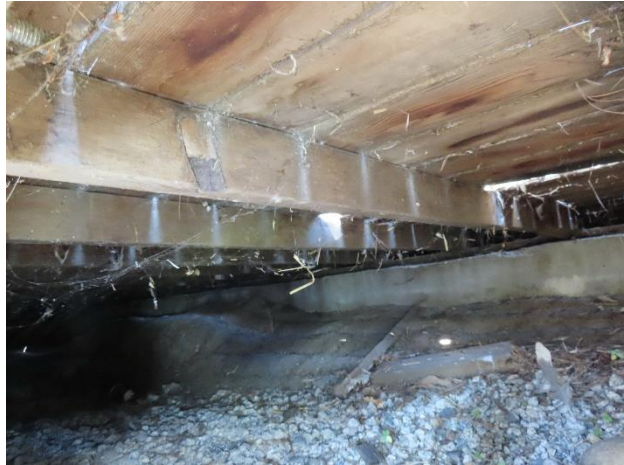
at the building's east cripple wall. The eastern edges of the deck appear to be supported by a short concrete foundation wall (Figure 8). The northern edge of the deck is protected by a wood guard rail (Figure 9). The southwest edge of the deck is elevated above grade by 20 inches. While the regular code does not require edge protection at this height, a wood bulletin board has been installed along the elevated edge (Figure 10).

Figure 8. View of framing and foundation beneath the east deck.

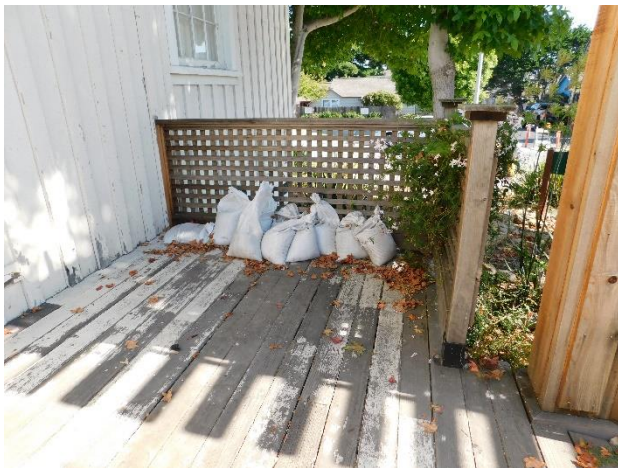
Figure 9. Wood guard rail at the north edge of the east deck. Note the paint remnants at the deck boards closest to the building.

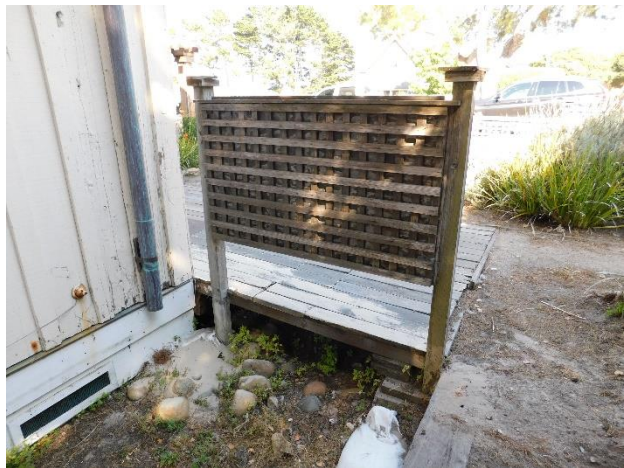
Figure 10. The back face of a bulletin board at the exposed edge at the southwest corner of the east deck.

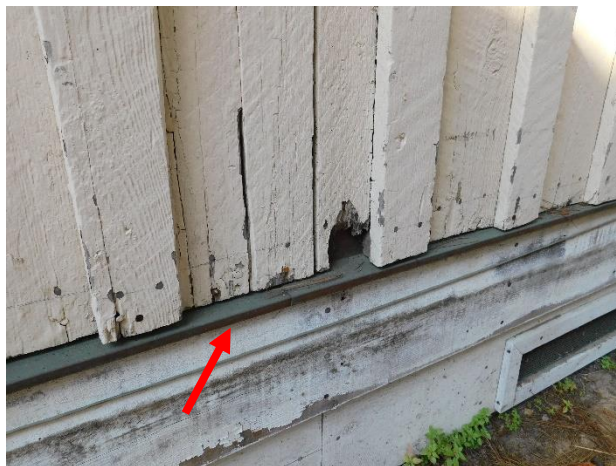
The exterior walls of the main hall and ancillary rooms are clad with vertical, painted board and batten siding fastened directly to wood framing (Figure 23). There is no sheathing or weather barrier. The boards are 12 inches wide and 5 feet 10 inches to 10 feet 4 inches tall. The battens are 3 7/8 to 4 1/4 inches wide. The cripple walls are clad with painted horizontal wood boards. There is metal flashing at the water table below the vertical board and batten siding at the cripple wall of the main hall (Figure 24). There is no flashing at the water table of the ancillary rooms (Figure 25).

Figure 24. Metal flashing (arrow) at water table on south facade of main hall.

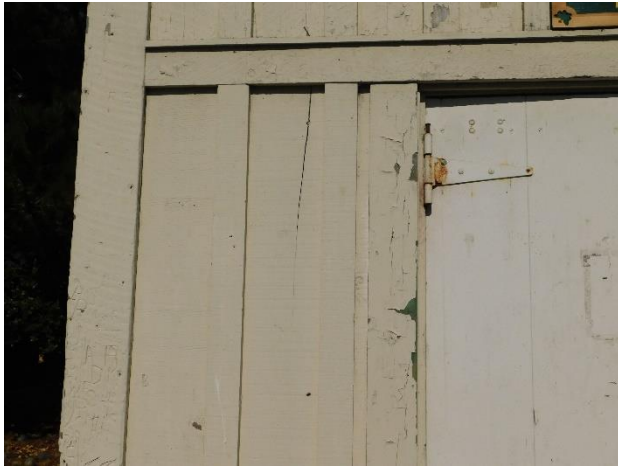
- Less than 6 inches of clearance between the soil and the bottom of wood cladding.
- Missing, weathered, and peeling paint throughout, especially near the base of board and batten walls (Figure 25 and Figure 26).
- Split or damaged boards (Figure 27).
- Soft wood and biological growth at the base of vertical boards, likely caused by prolonged exposure to moisture (Figure 28).
- Carved graffiti.
- Isolated areas of staining from corroded fasteners.

Figure 27. Example of splitting board and batten cladding.

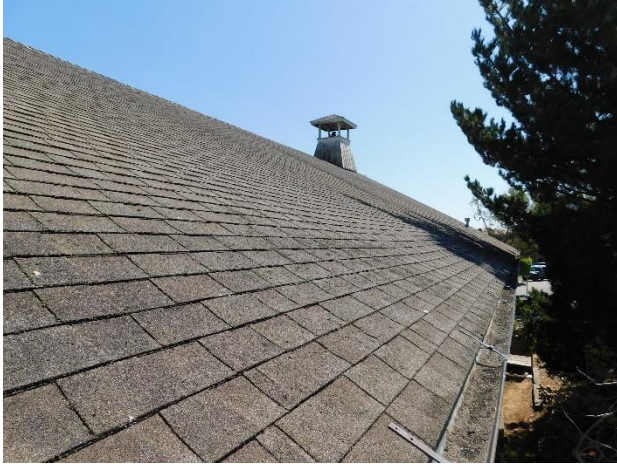
- The areas of shingles observed are generally in serviceable condition, with signs of minor weathering and biological growth.
  - There is greater biological growth on the north side of the roof of the ancillary rooms and at shaded areas of the roofs (Figure 51).

Figure 46. Condition at the south half of the main hall roof.

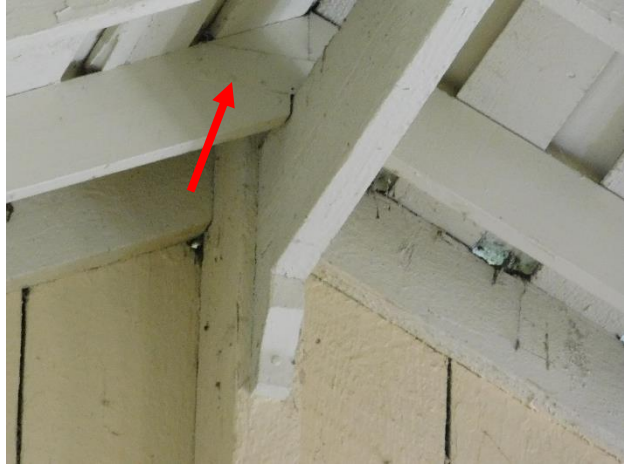
Figure 67. Corbel detail at ends of ridge beam. Also note the strapping at the ridge of the new additional rafters for the reconstructed belfry (arrow).

- WJE could not fully confirm that the existing anchorage of the belfry matches the 1990 construction documents provided. The new additional 2x6 rafters shown on the drawings are visible at the interior. Some strapping could be observed at the ridge of the new rafters, but it differed from the drawings (Figure 67). Other strapping shown in the drawings could not be observed due to obstructions and limited access.
  - It is unclear how the belfry is waterproofed and integrated with the roofing, especially where straps and fasteners for plate anchors are shown on the 1990 construction documents as penetrating the roofing.

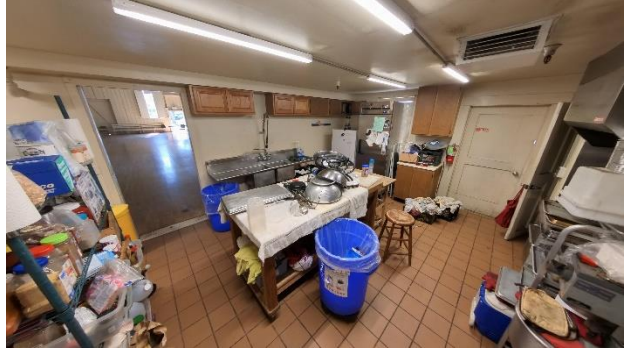
Figure 73. View of kitchen looking southeast.

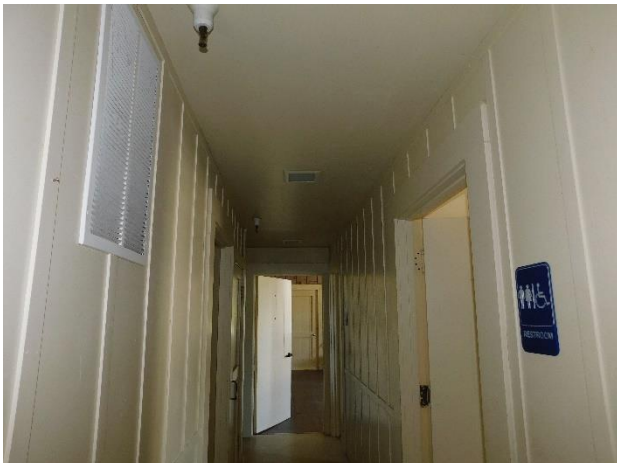
Figure 74. View of central hallway.

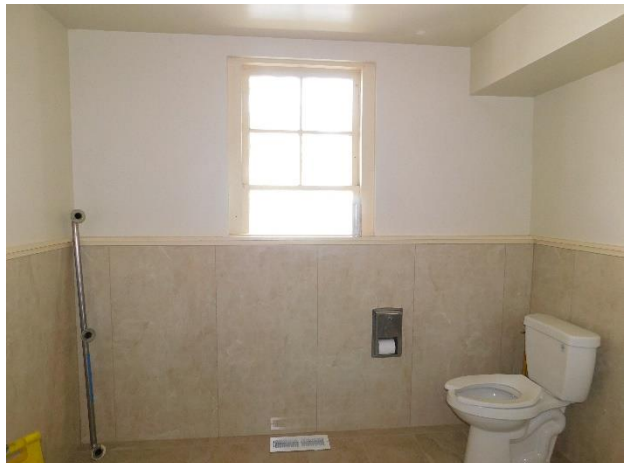
Figure 75. View of men's bathroom with 4/1, wood, double-hung window.

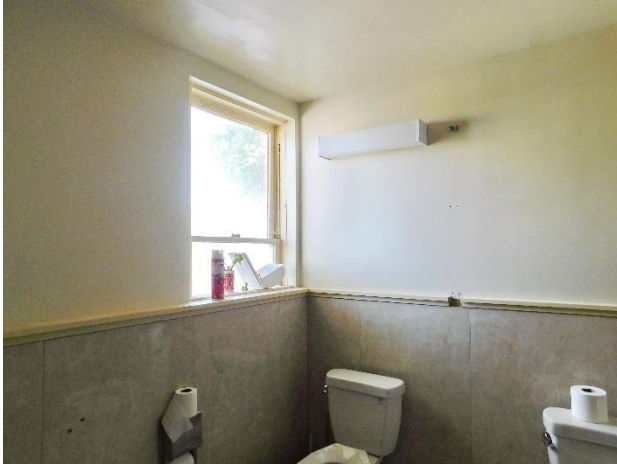
Figure 76. View of women's bathroom with a 1/1, wood, double-hung window.

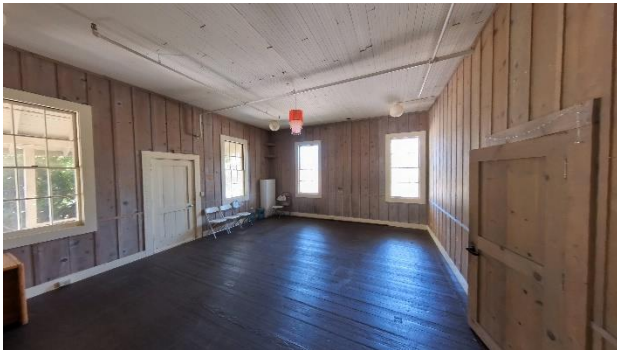
Figure 77. View looking northwest of northwest multipurpose room.

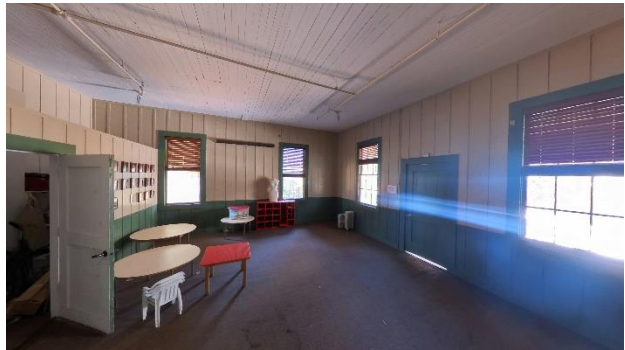
Figure 78. View looking southwest of southwest multipurpose room.

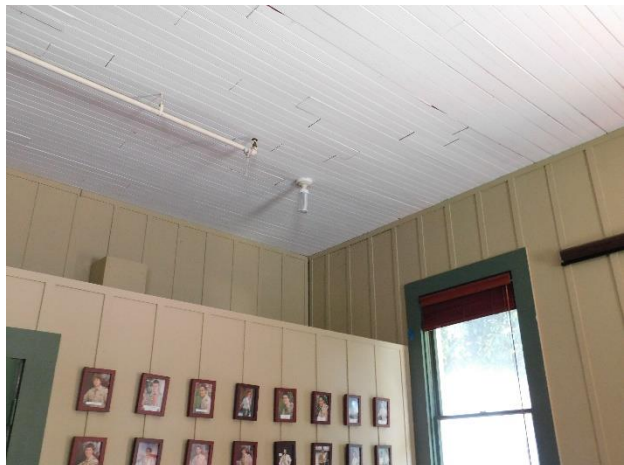
- There are gaps between ends of boards throughout the ceiling of the northwest and southwest multipurpose rooms (Figure 81 and Figure 82). The ceiling of the northwest multipurpose room exhibits the largest gaps.
- There is a small area of water staining at an abandoned ceiling penetration in the northwest multipurpose room that is indicative of water intrusion (Figure 83).

Figure 82. Smaller gaps between ceiling boards in the southwest multipurpose room.

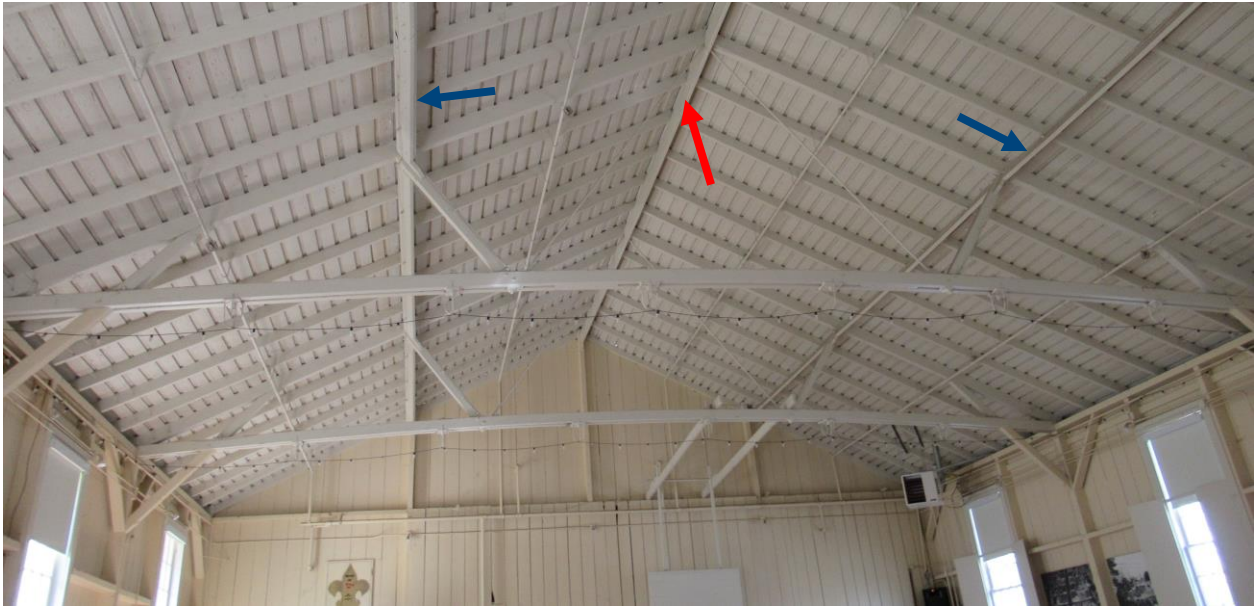
The main hall roof system consists of 2 inch by 6 inch rafters spaced at approximately 3 feet on center, supported by a ridge beam at the peak of the gable roof and a strongback halfway down the slope of the roof on either side (Figure 84). Three trusses, spaced at approximately 18 feet, span across the gable and support the ridge beam and strongbacks. The trusses consist of 4 inch by 8 inch top chords, a double 3 inch by 6 inch bottom chord, steel tie rod inner diagonal members, and 4 inch by 4 inch wood diagonal members (Figure 85).

Figure 84. Roof system in the main hall. A ridge beam (red arrow) and strong backs (blue arrows) support roof rafters and span between trusses.

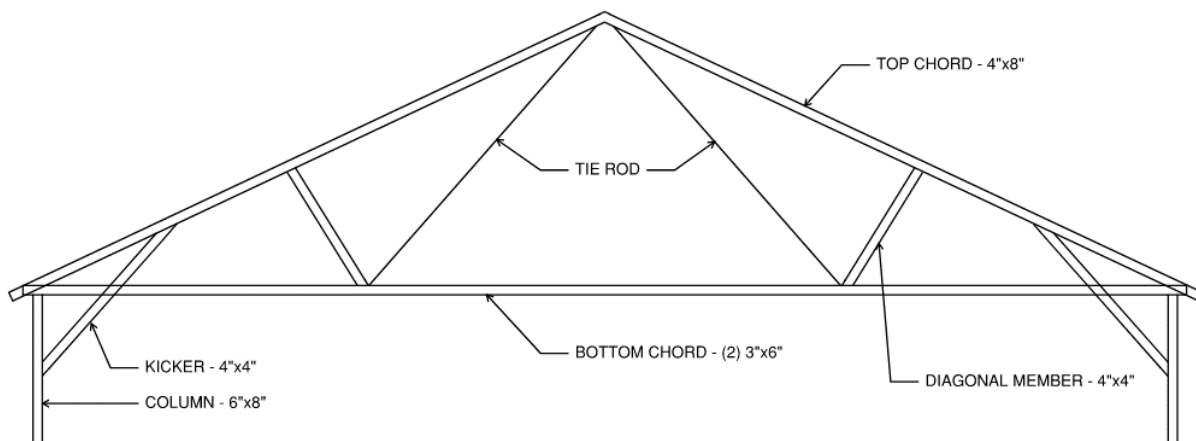
Figure 85. Conceptual elevation of roof truss.

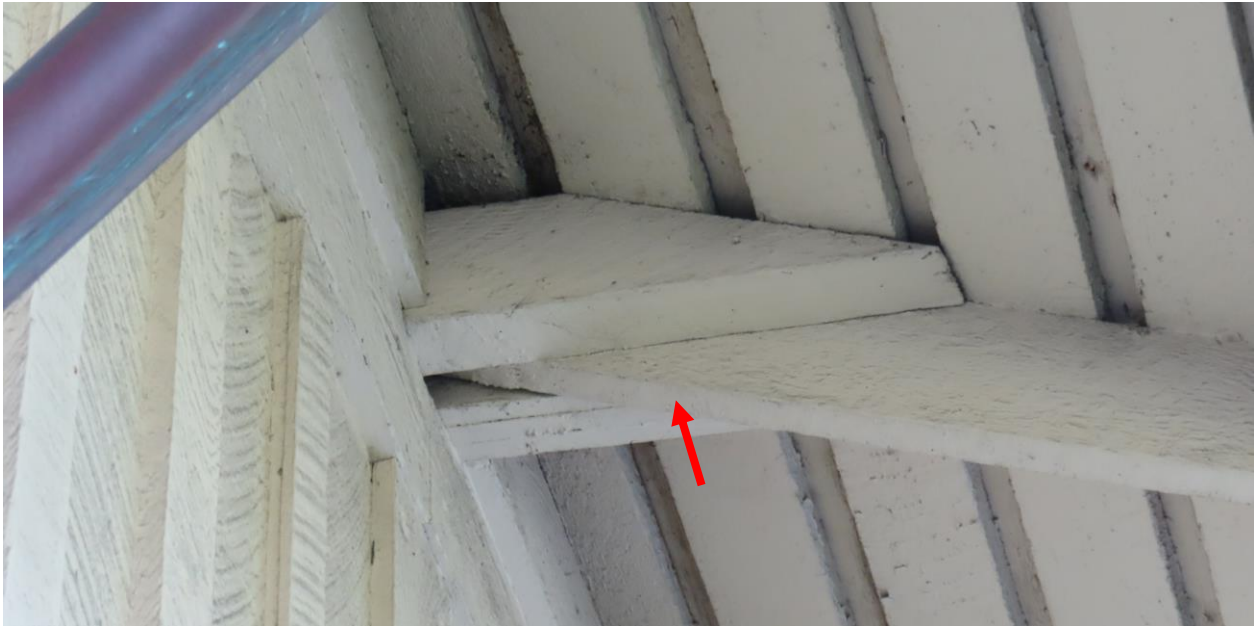
At each end, the truss is vertically supported on a 6inch by 8 inch column, with a pair of 2 inch by 6 inch kickers in the plane of the wall and a 4inch by 4 inch kicker in the plane of the truss. The top and bottom chords of the truss continue past the column and wall framing to the outside of the building. The heel connection where the two intersect appears to consist of two to three face nails on each side of connection (Figure 86).

Figure 86. Heel connection of truss just outside the exterior wall of the main hall (arrow).

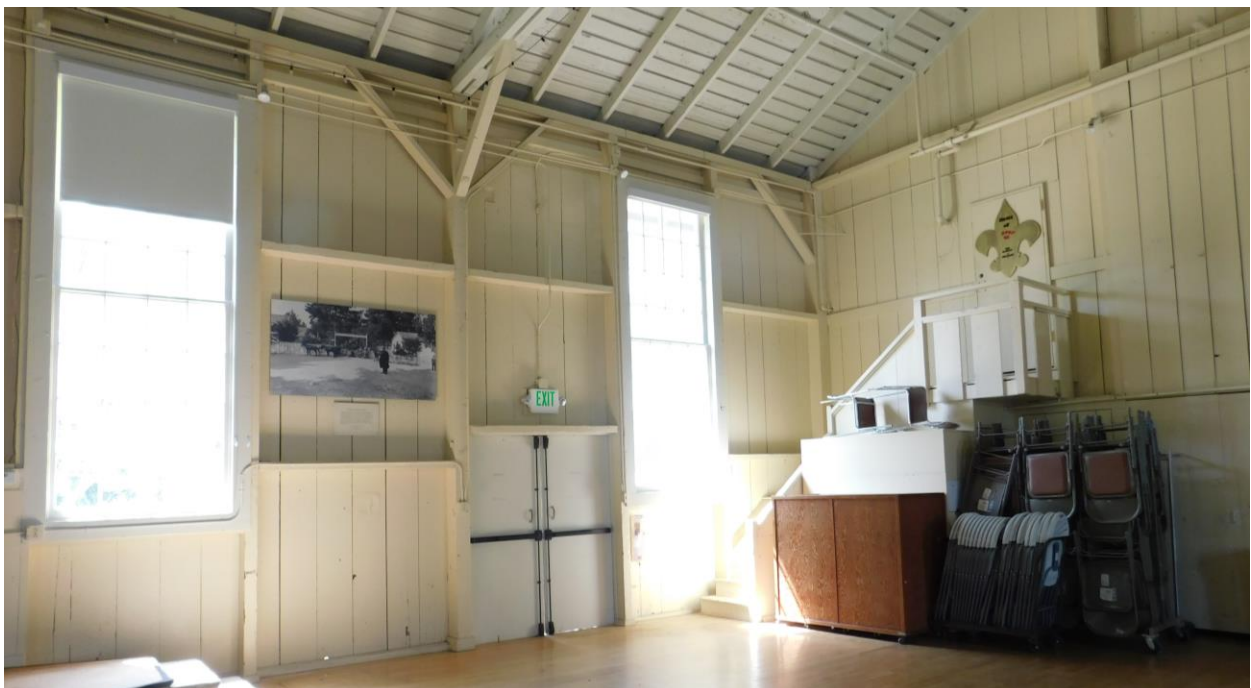
The wall framing in the main hall consists of a 4 inch by 9 inch top plate, 4 inch by 8 inch "studs" on either side of windows and doors, and 4inch by 8 inch intermediate horizontal elements (girts) at third points up the wall height (Figure 87). Exterior vertical 1 inch by 12 inch siding boards extend from the floor to the roof and are nailed to the top and bottom wall plates and the girts. These vertical boards also appear to be the primary lateral force-resisting system for the main hall.

Figure 87. Typical wall framing in main hall.

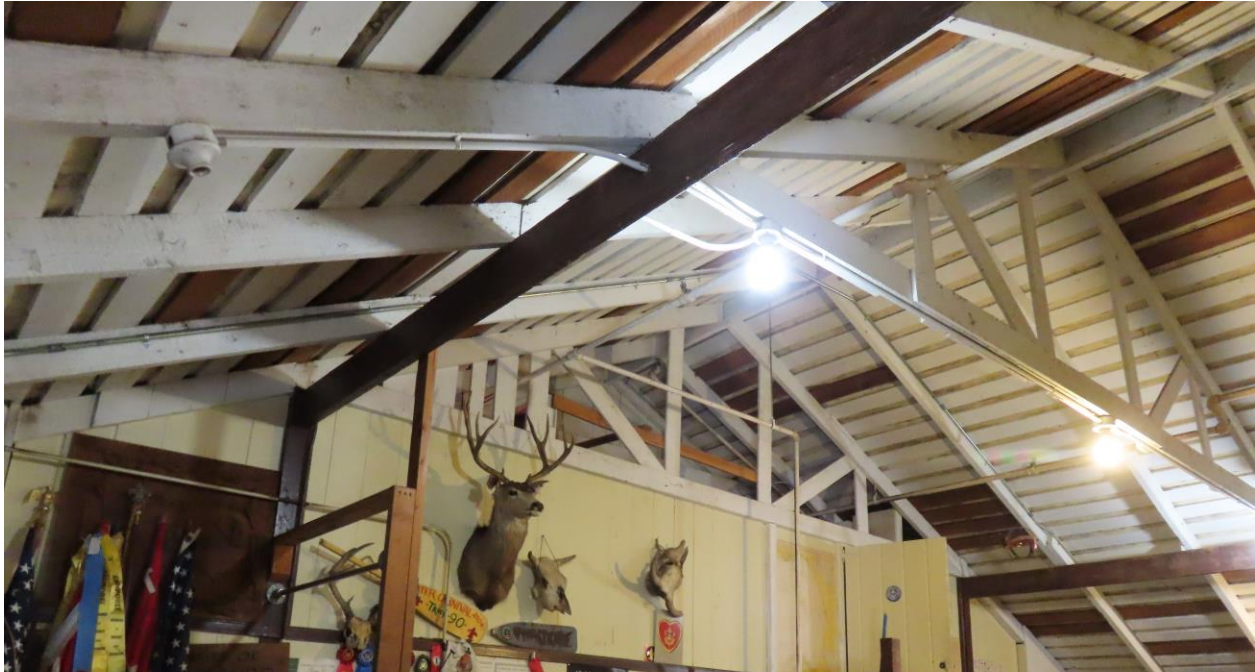
At the western ancillary rooms, more of the framing is concealed than in the main hall. The roof structure for the western area consists of 2 inch by 6 inch rafters at approximately 30 inch spacing with a ridge board, exterior walls, and strongbacks halfway down the gable sides. Every third or fourth pair of rafters is stiffened by additional wood boards in an approximation of a truss (Figure 88). The ceiling joists were not accessible, but are presumed to match the 2 inch by 8 inch floor joists in the attic used by the Boy Scouts.

Figure 88. Roof framing in Boy Scout attic area.

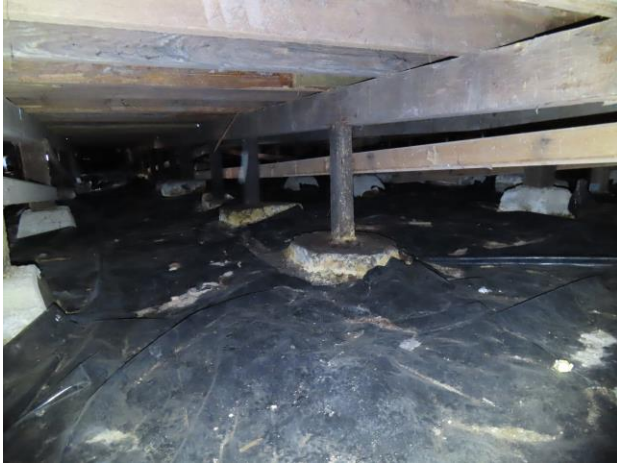
The floor framing in both areas of the building is typically 2 inch by 6 inch joists at 16 inch spacing. The joists span between 6 inch by 8 inch beams spaced approximately 5 to 6 feet apart, supported on wood posts and isolated shallow concrete footings (Figure 89). A shallow concrete strip footing is present around the perimeter of the building, with a partial height wood framed wall (cripple wall) that varies between approximately 12 and 30 inches in height (Figure 90). No concrete strip footing was observed below the full height wall that divides the main hall from the ancillary rooms.

Figure 89. Typical joists, beams, and posts supported on shallow concrete piers.

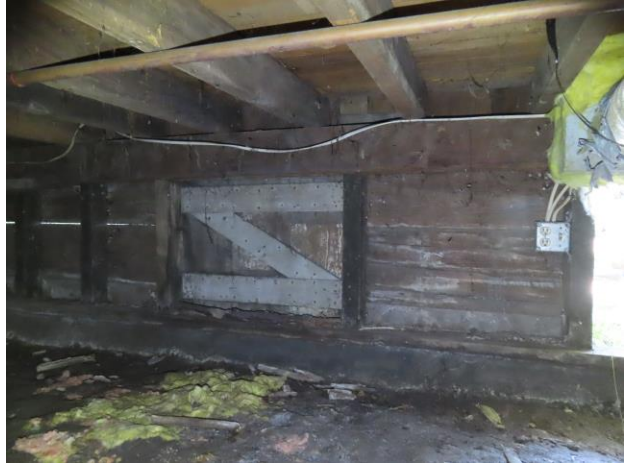
Figure 90. Exterior cripple wall framing

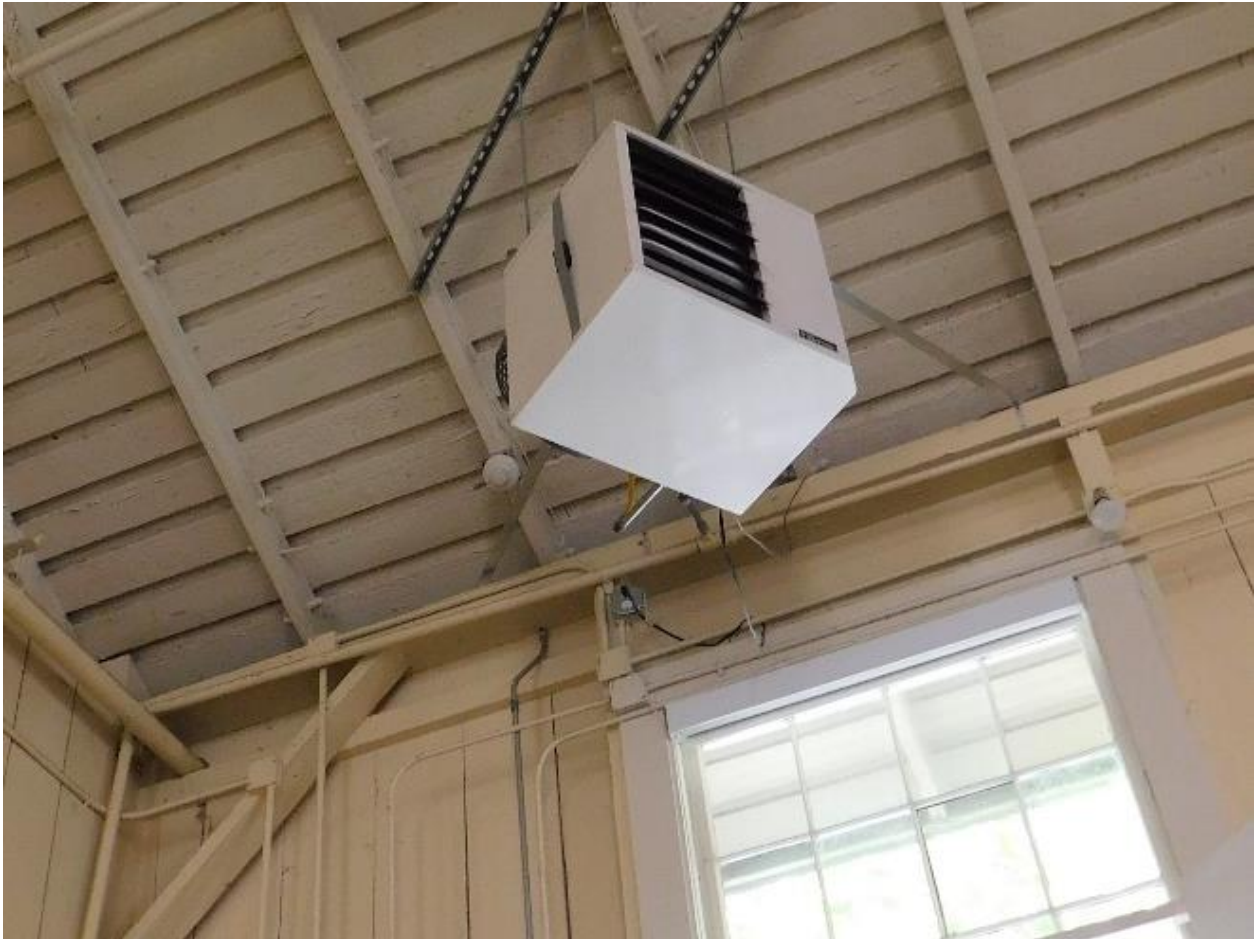
- Installation of new gas heaters over the windows of the main hall. WJE observed two presumed gas heating units, one each in the northwest and southeast corners of the main hall, though it is not clear when they were installed (Figure 95).

Figure 95. Gas heater in the northwest corner of the main hall.
